## FRASER & GRAY BUILDING SCHEMATIC DESIGN

# Port of Skagit - SWIFT Center Rehabilitation of Gray and Fraser Buildings

Port of Skagit - SWIFT Center  
**Gray and Fraser Buildings Feasibility Study**  
 Northern State Hospital Campus  
 Sedro-Woolley, WA 98284

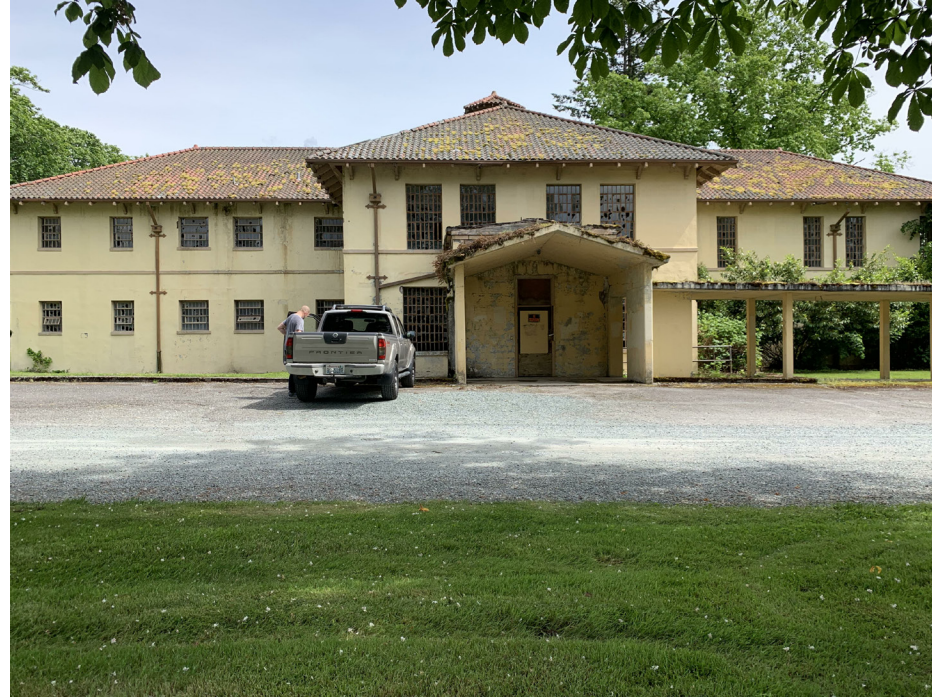
Image of the Existing Gray Building Exterior (Fraser Building Similar)

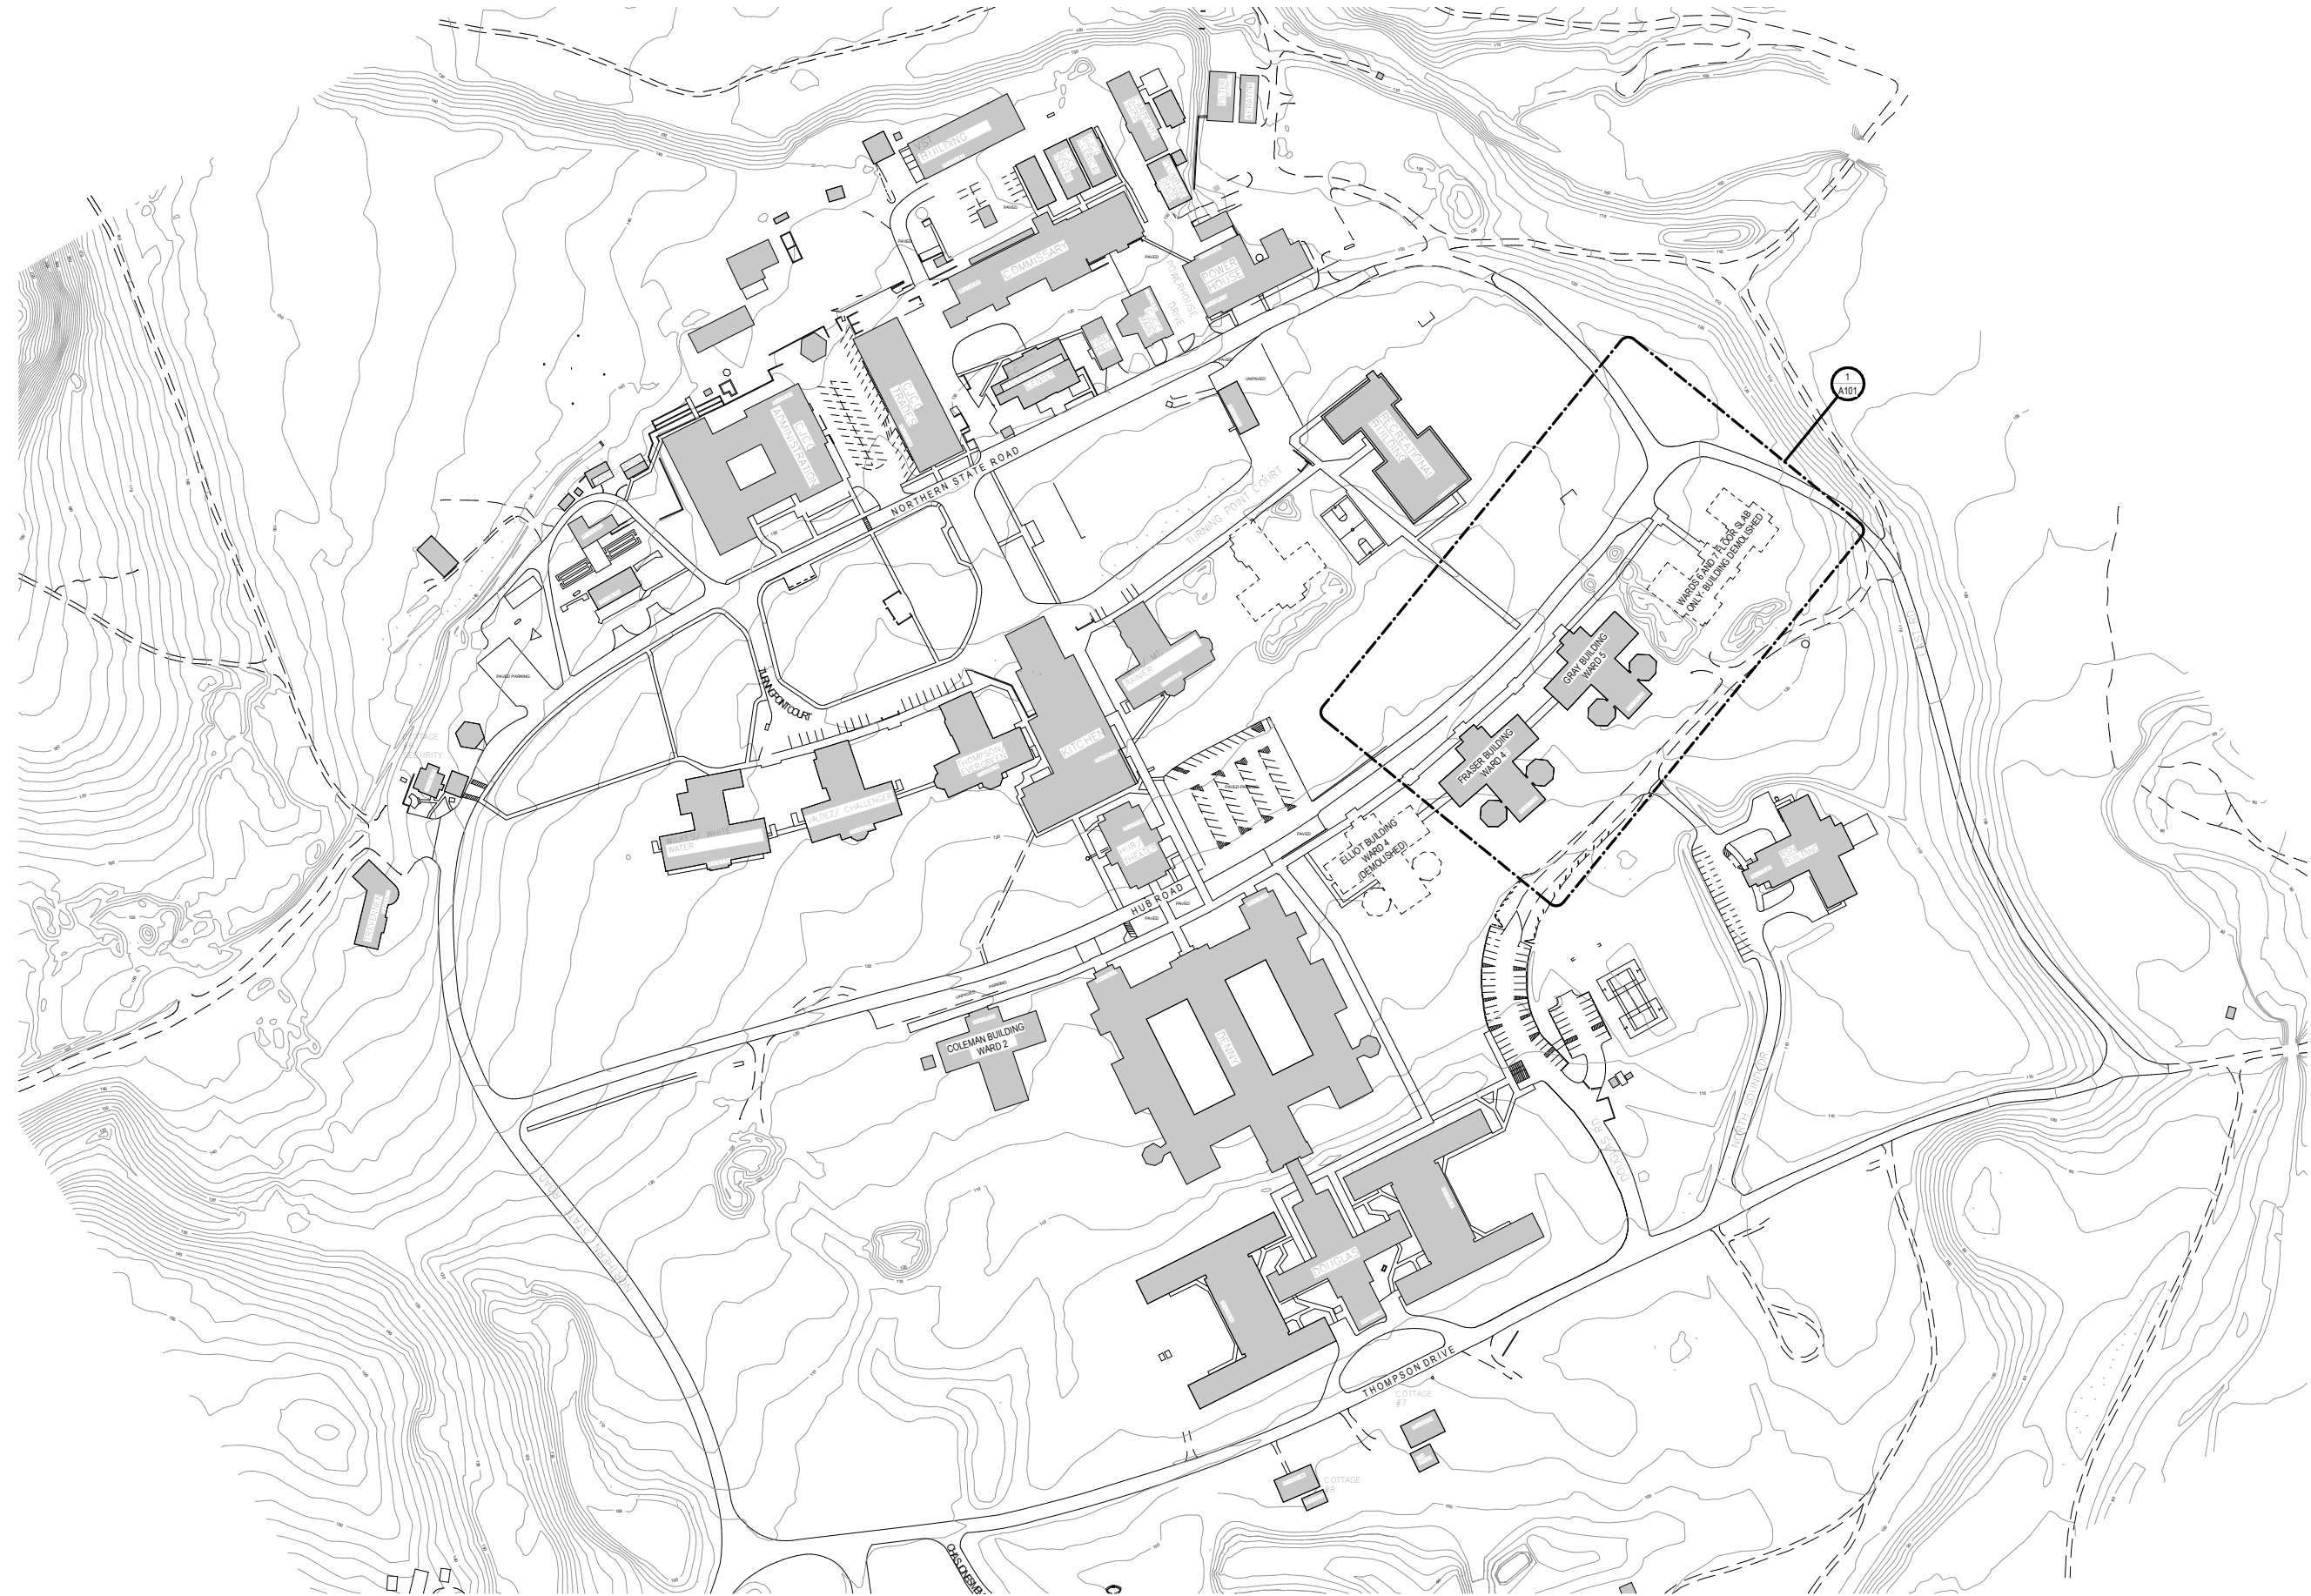
**G100**

1 Campus Plan  
 1" = 100'-0"

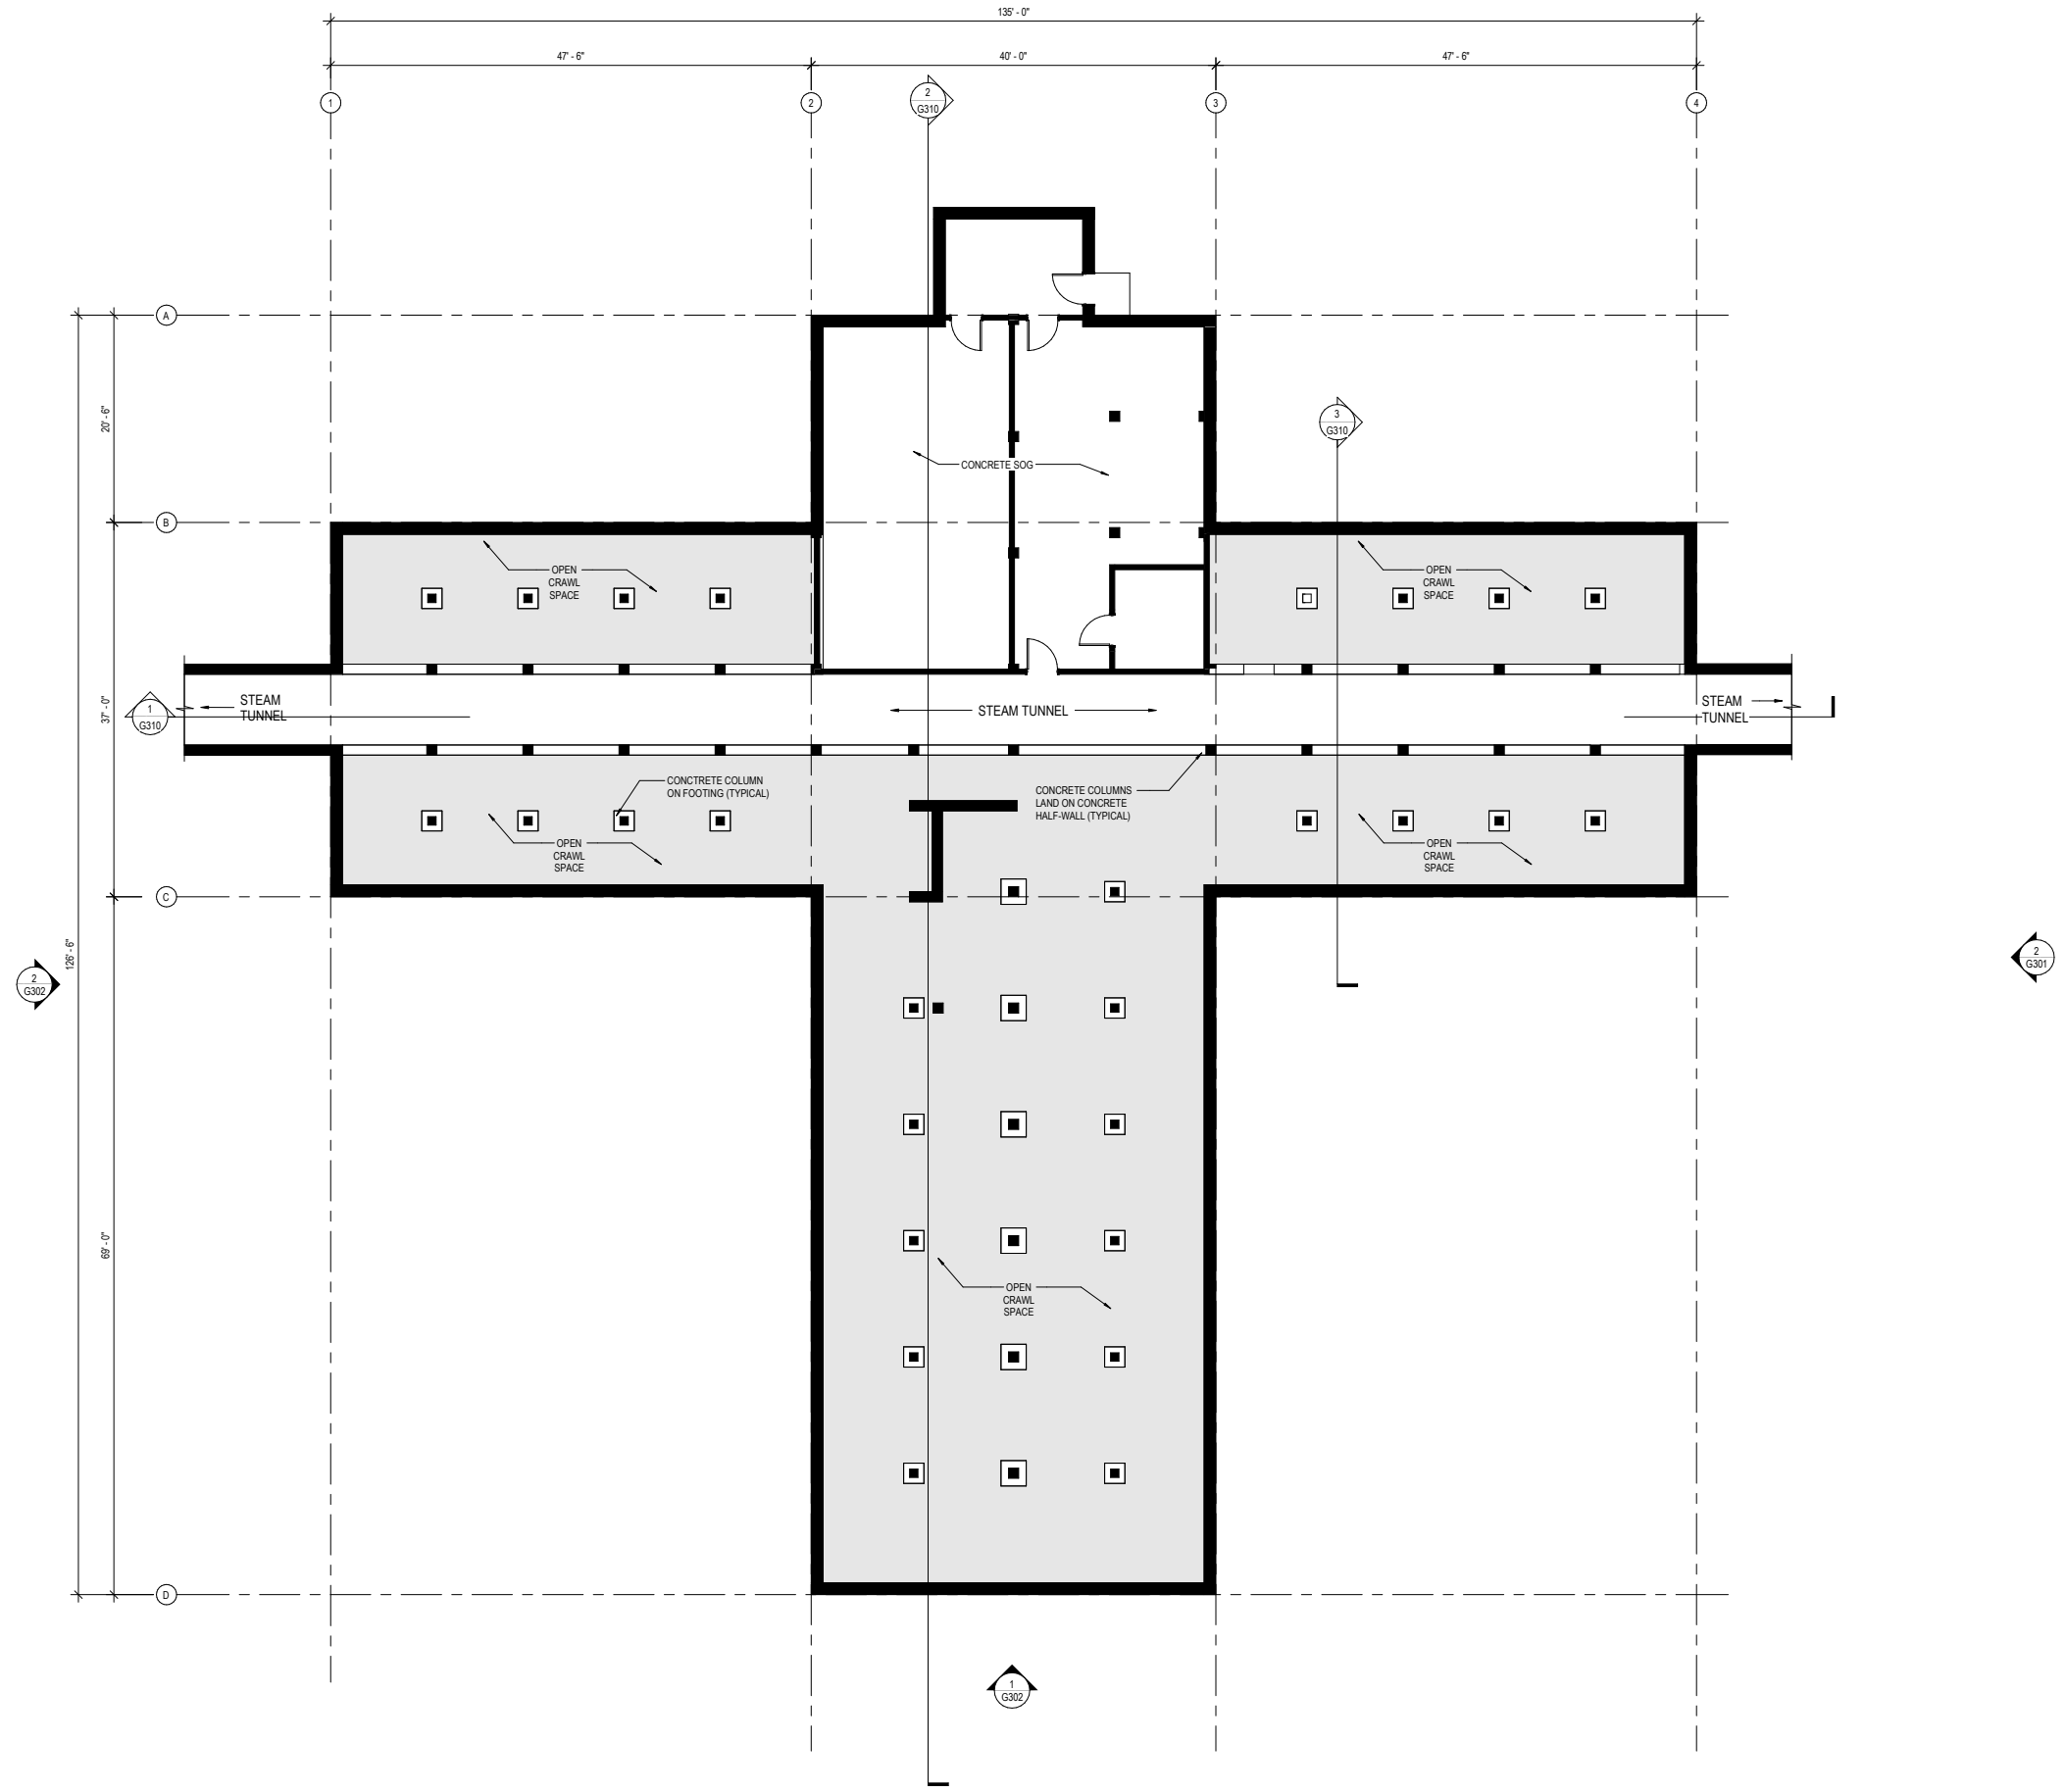
**G200**

1 Existing Basement Floor Plan  
 1/8" = 1'-0"

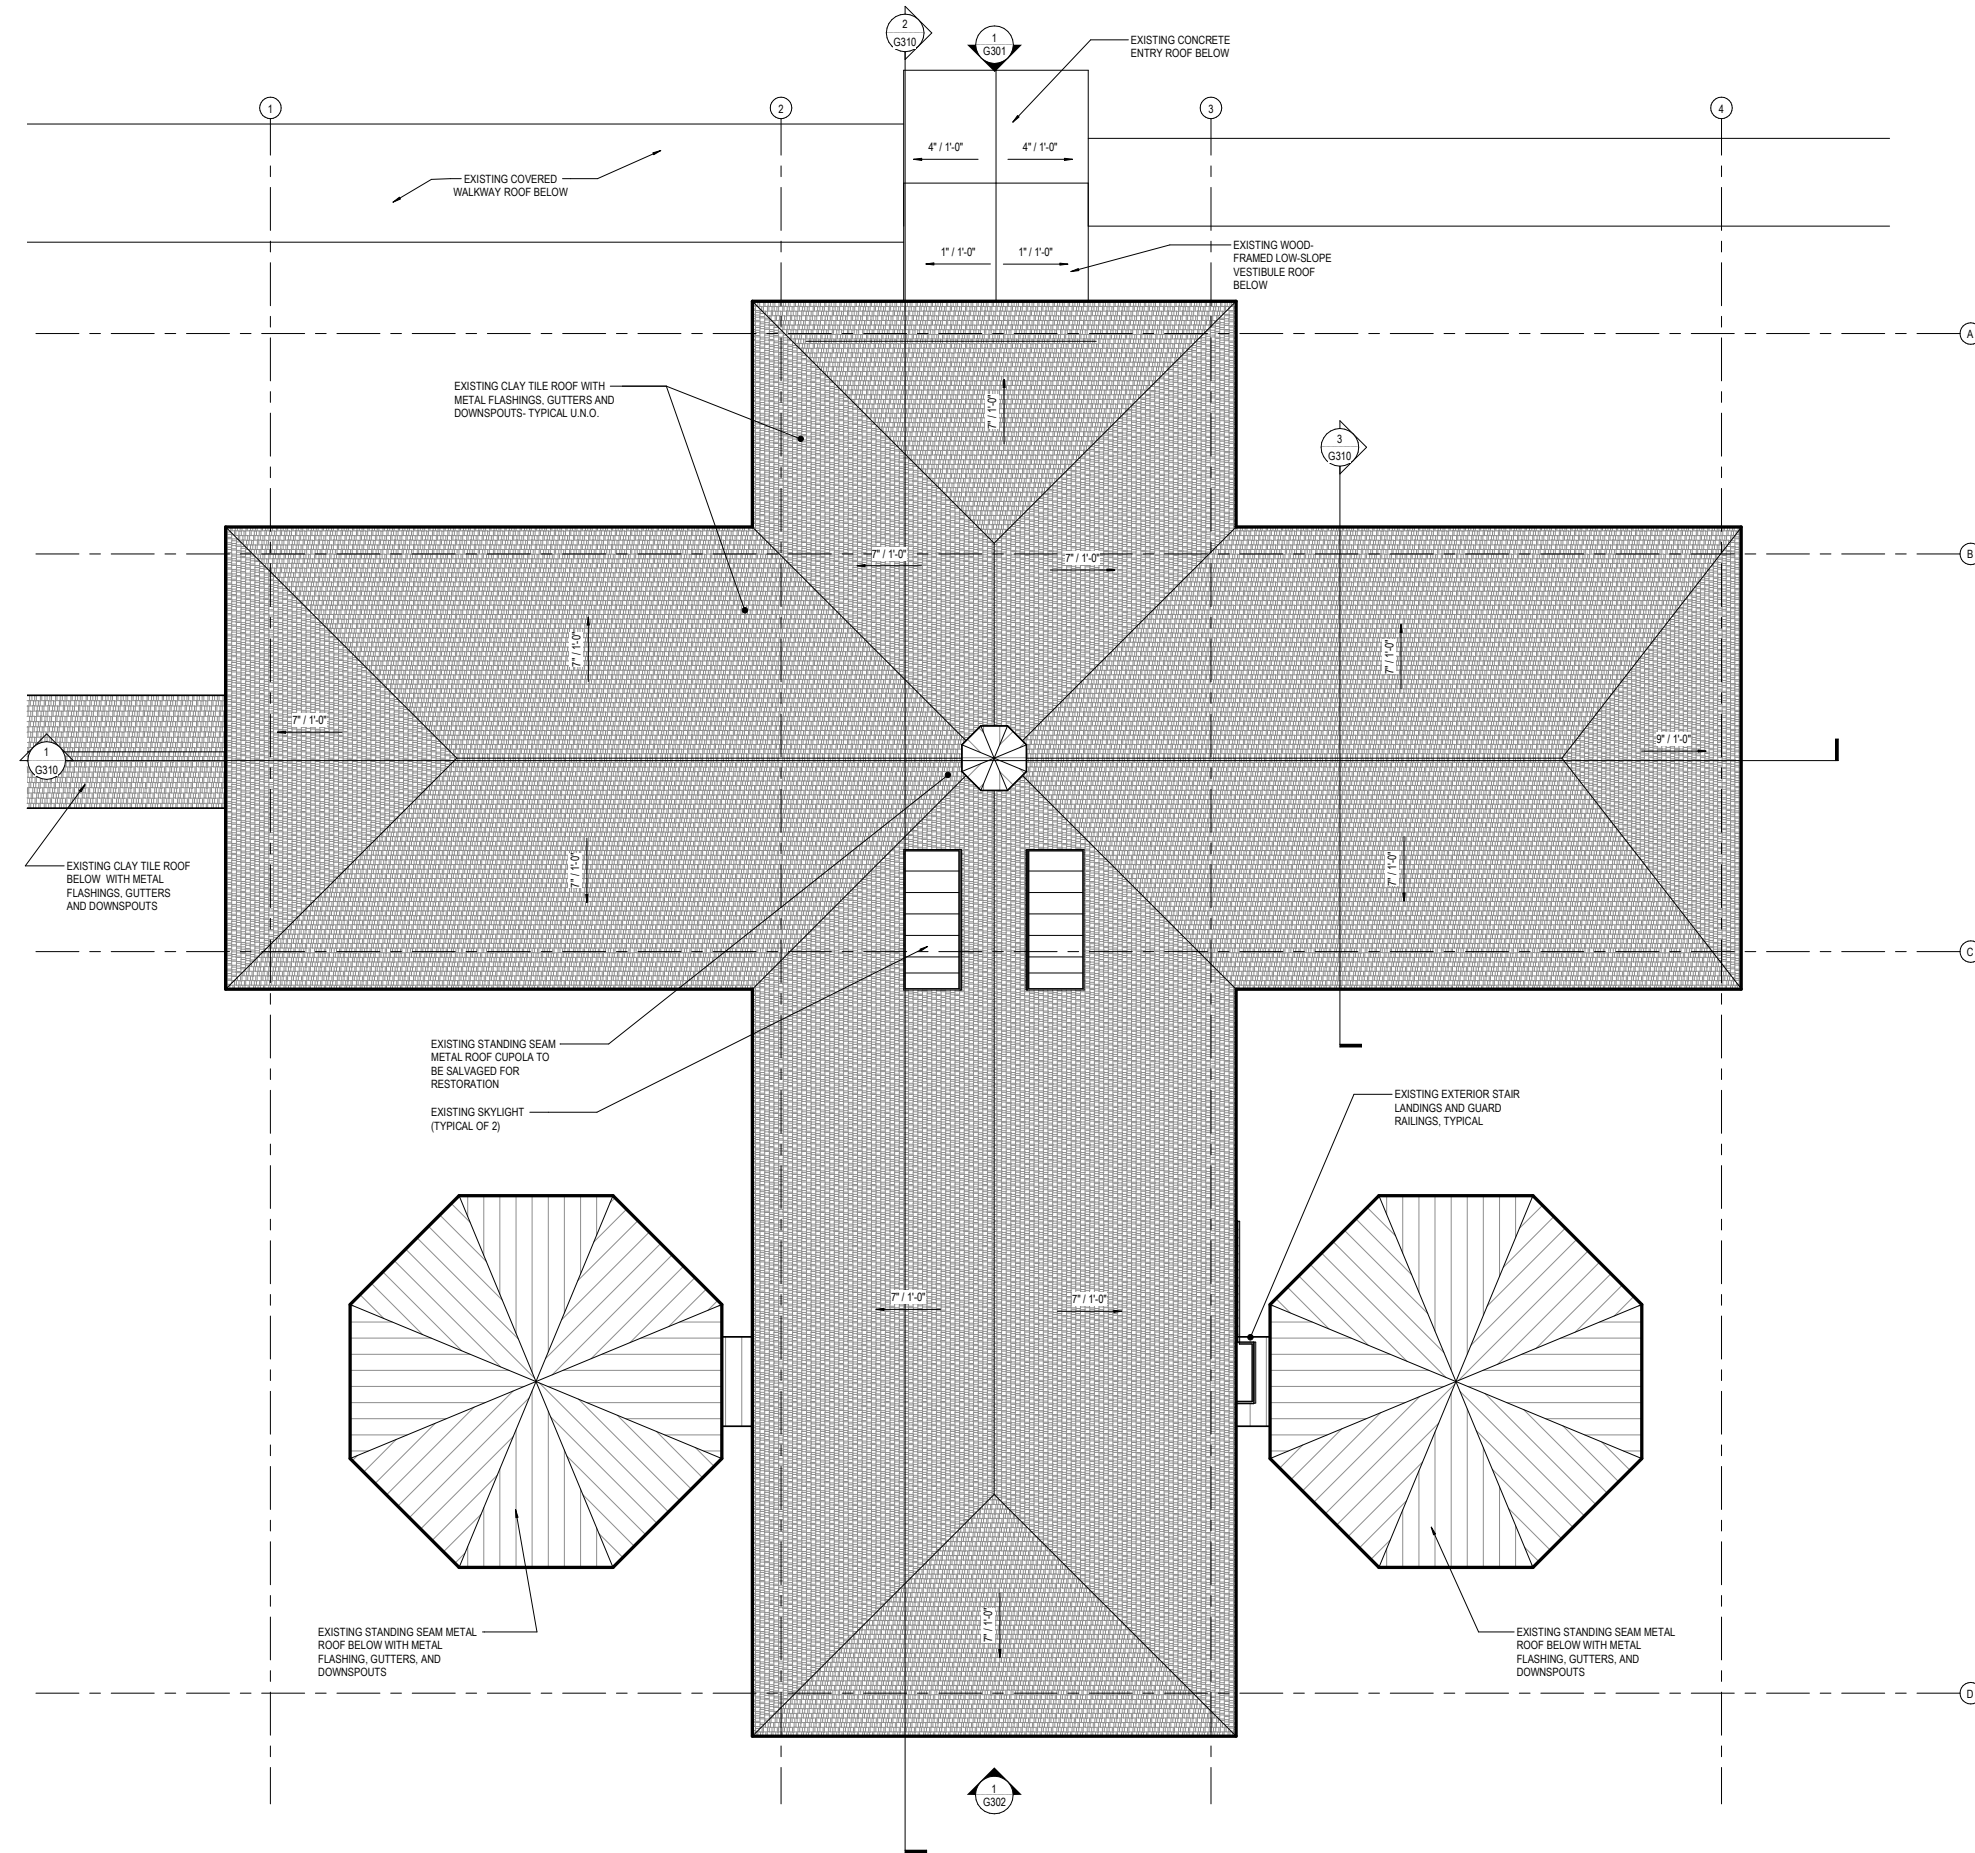
**G210**

1 Existing Roof Plan  
 1/8" = 1'-0"

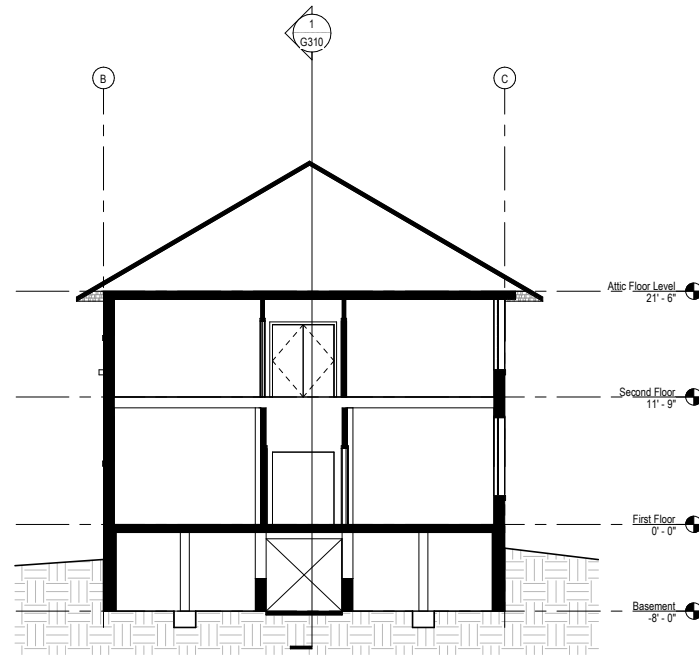
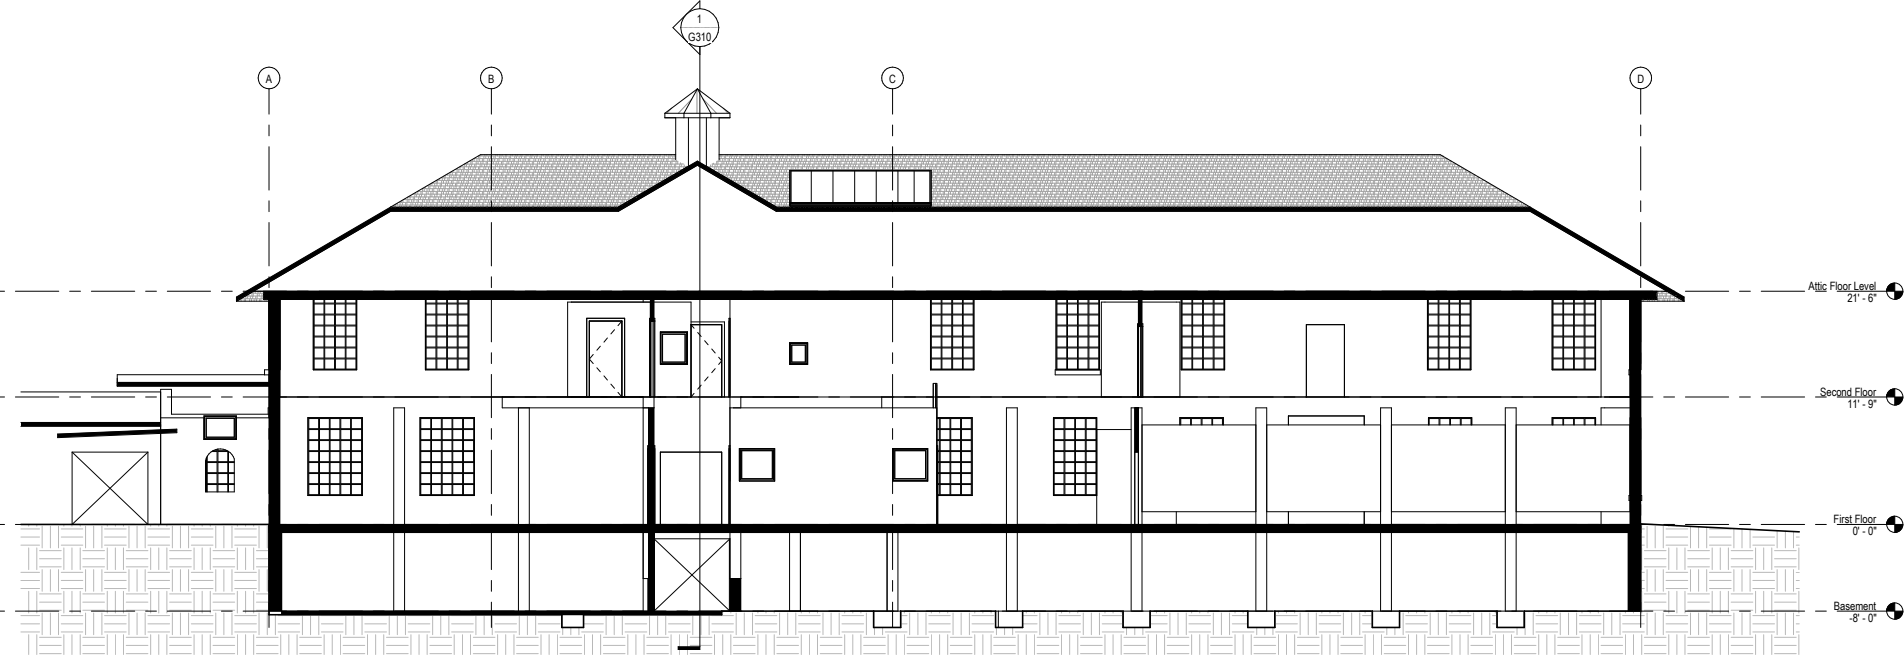
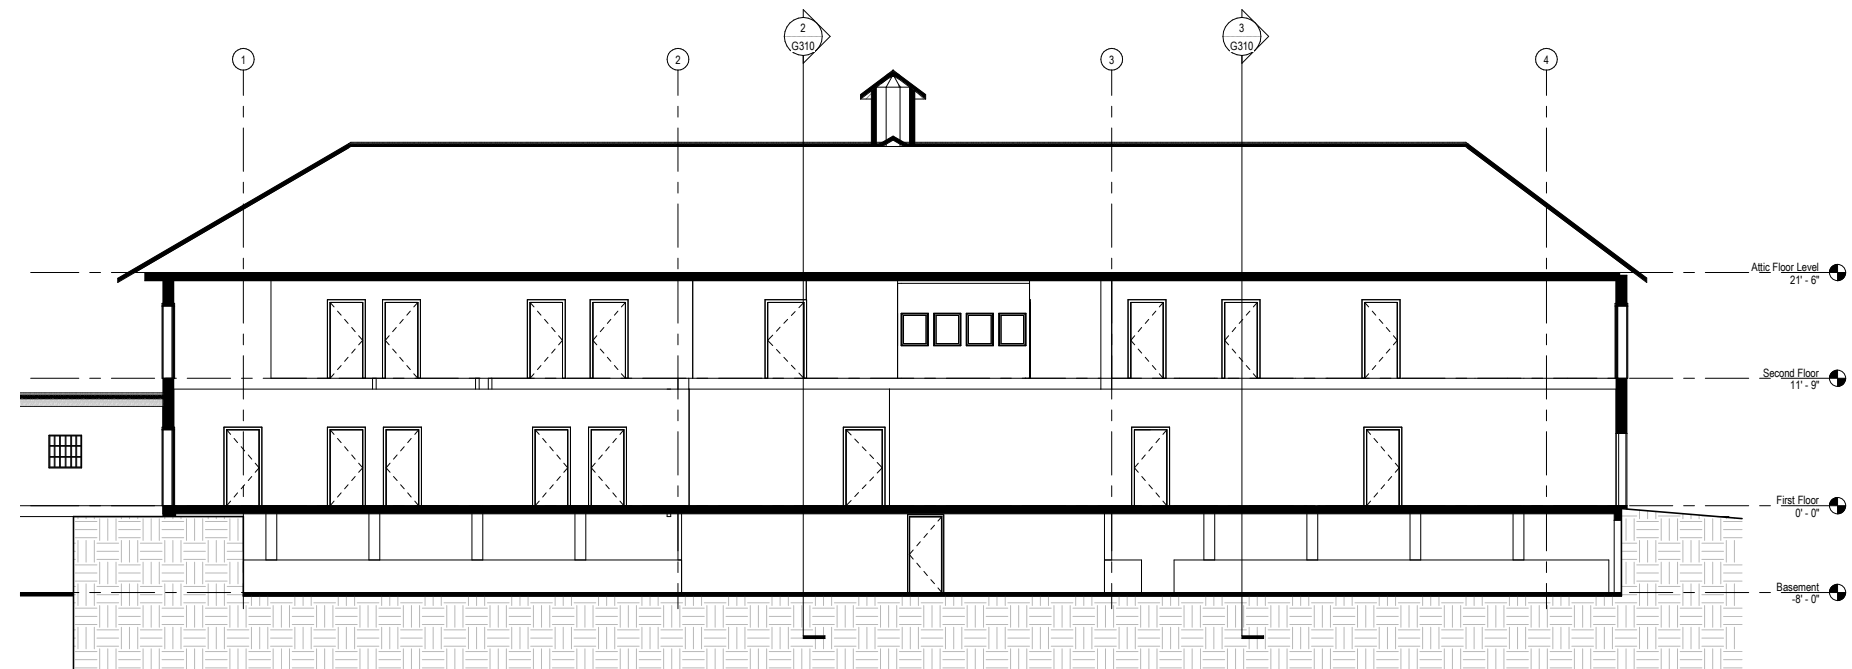
G310

3 Existing Section 3  
1/8" = 1'-0"

2 Existing Section 2  
1/8" = 1'-0"

1 Existing Section 1  
1/8" = 1'-0"

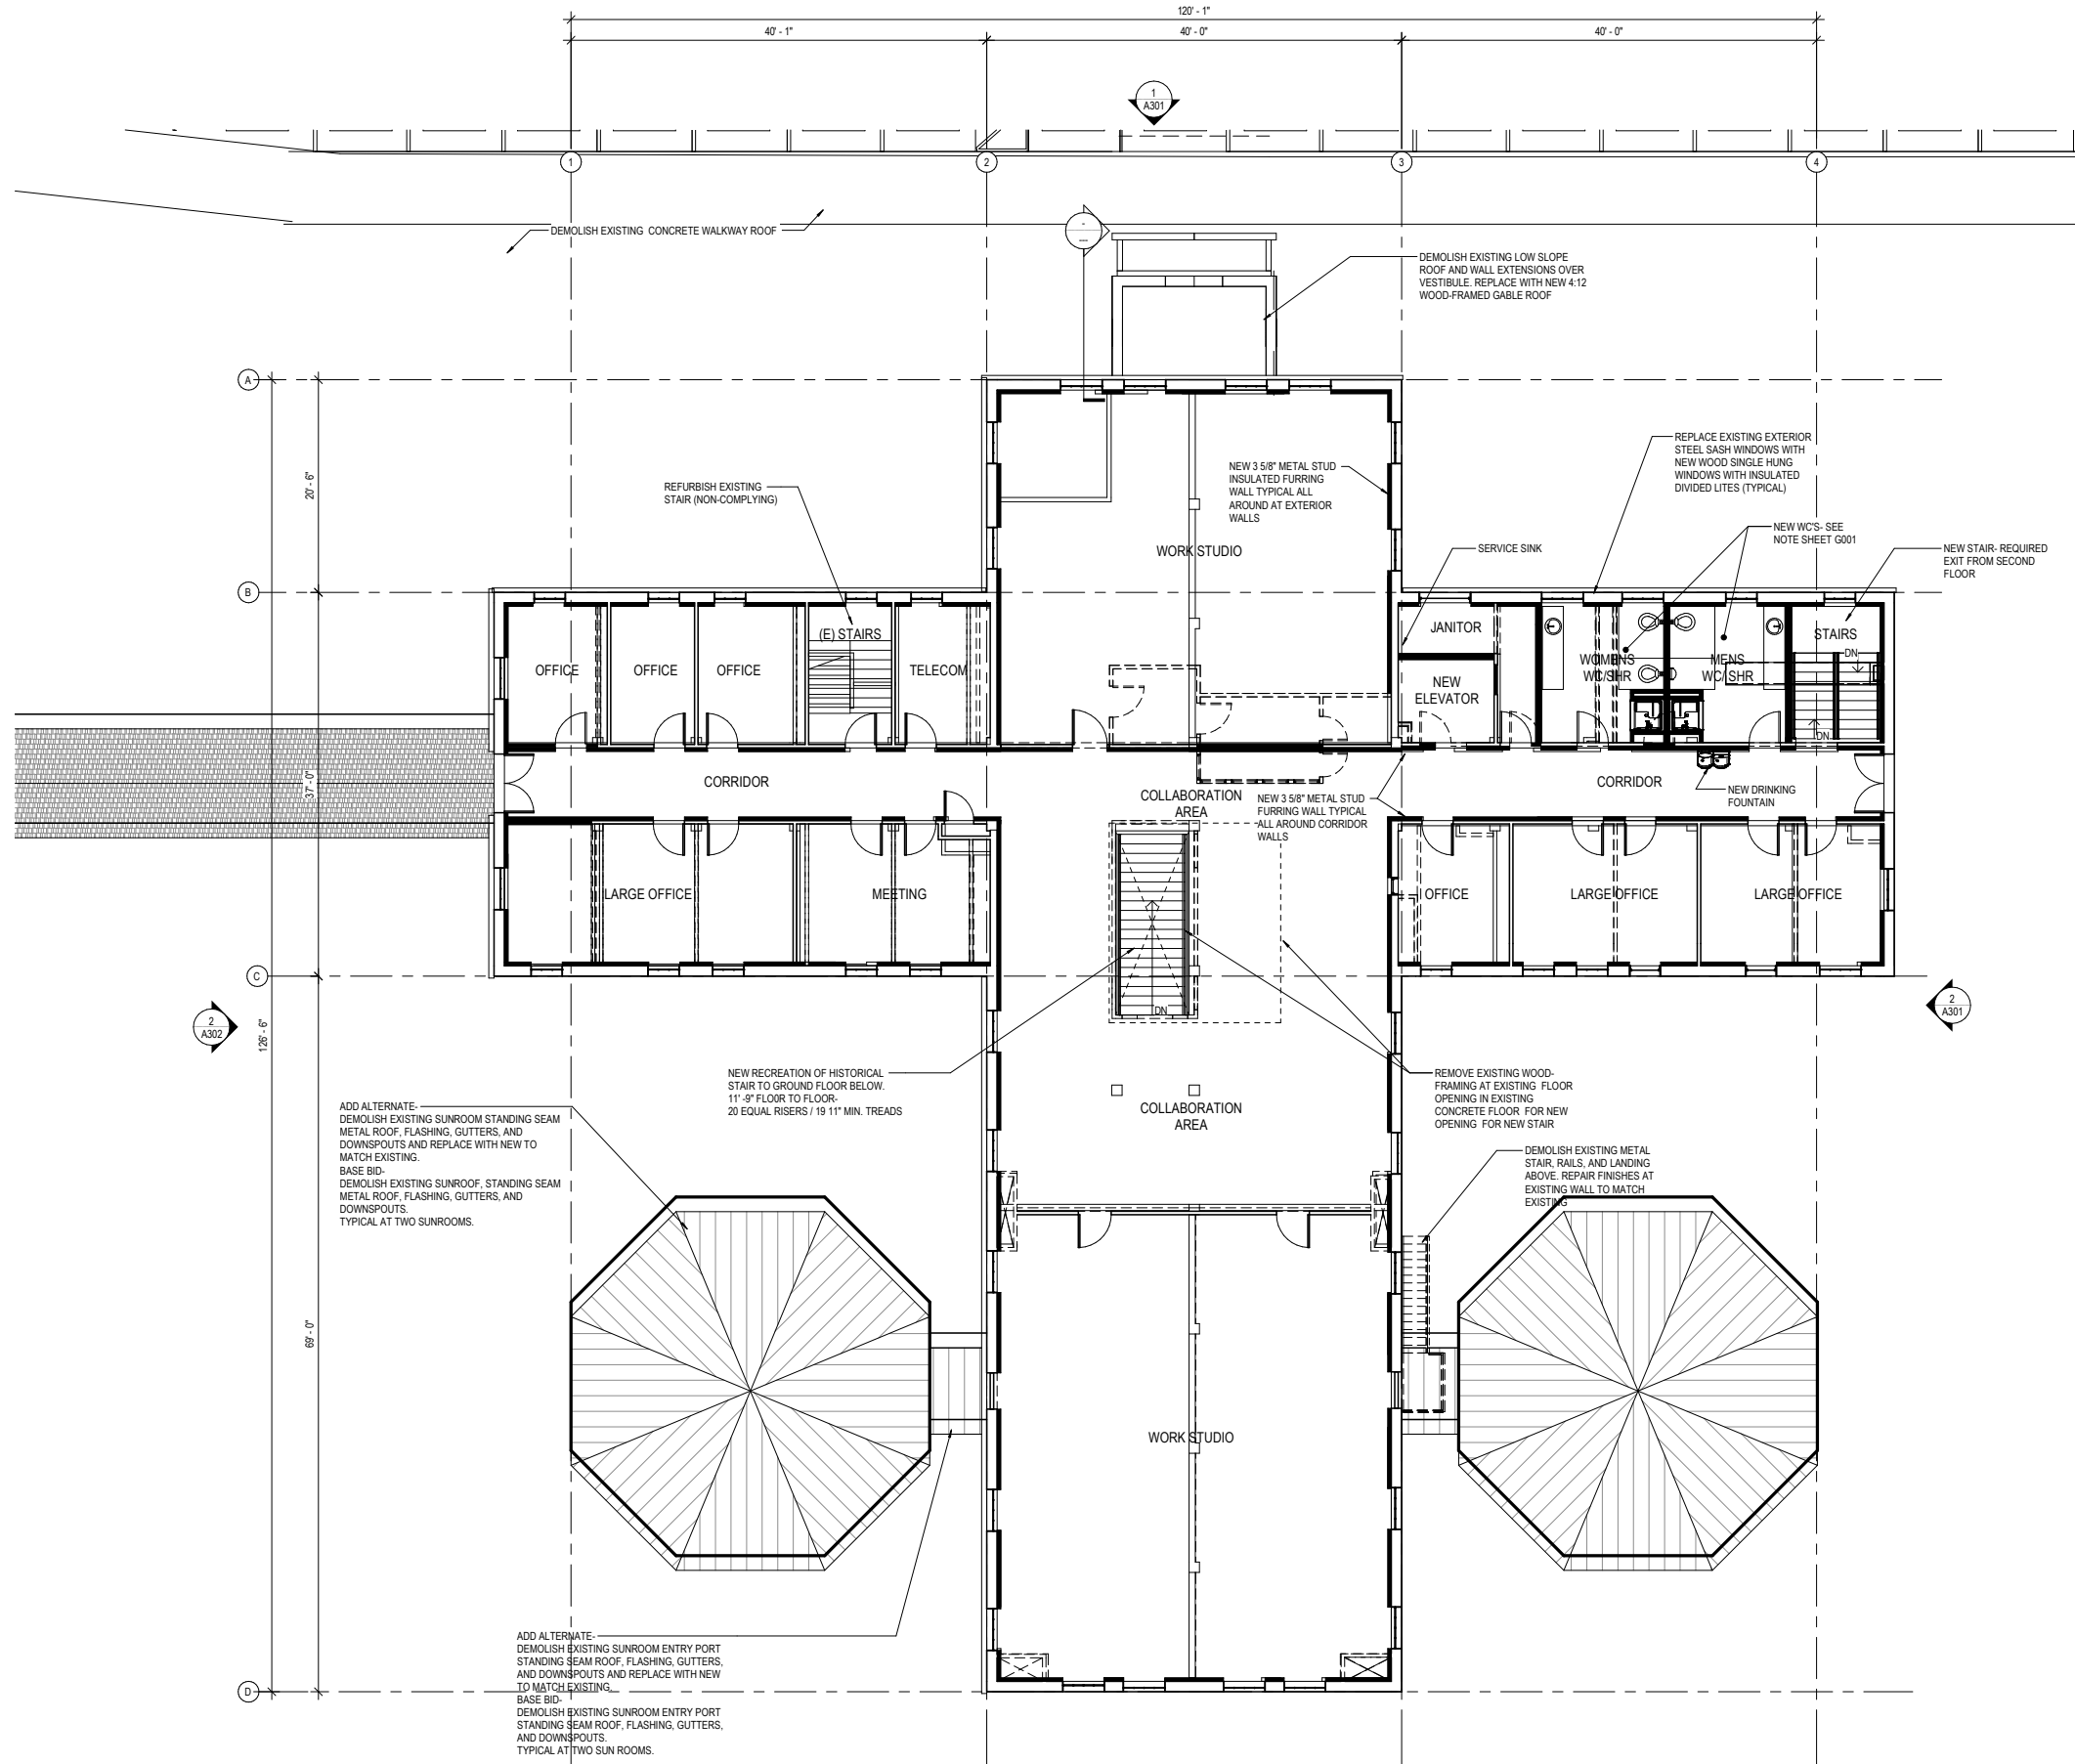
**1 Demo/Construction Level 2 Floor Plan 8,750 SF Gross**  
 1/8" = 1'-0"

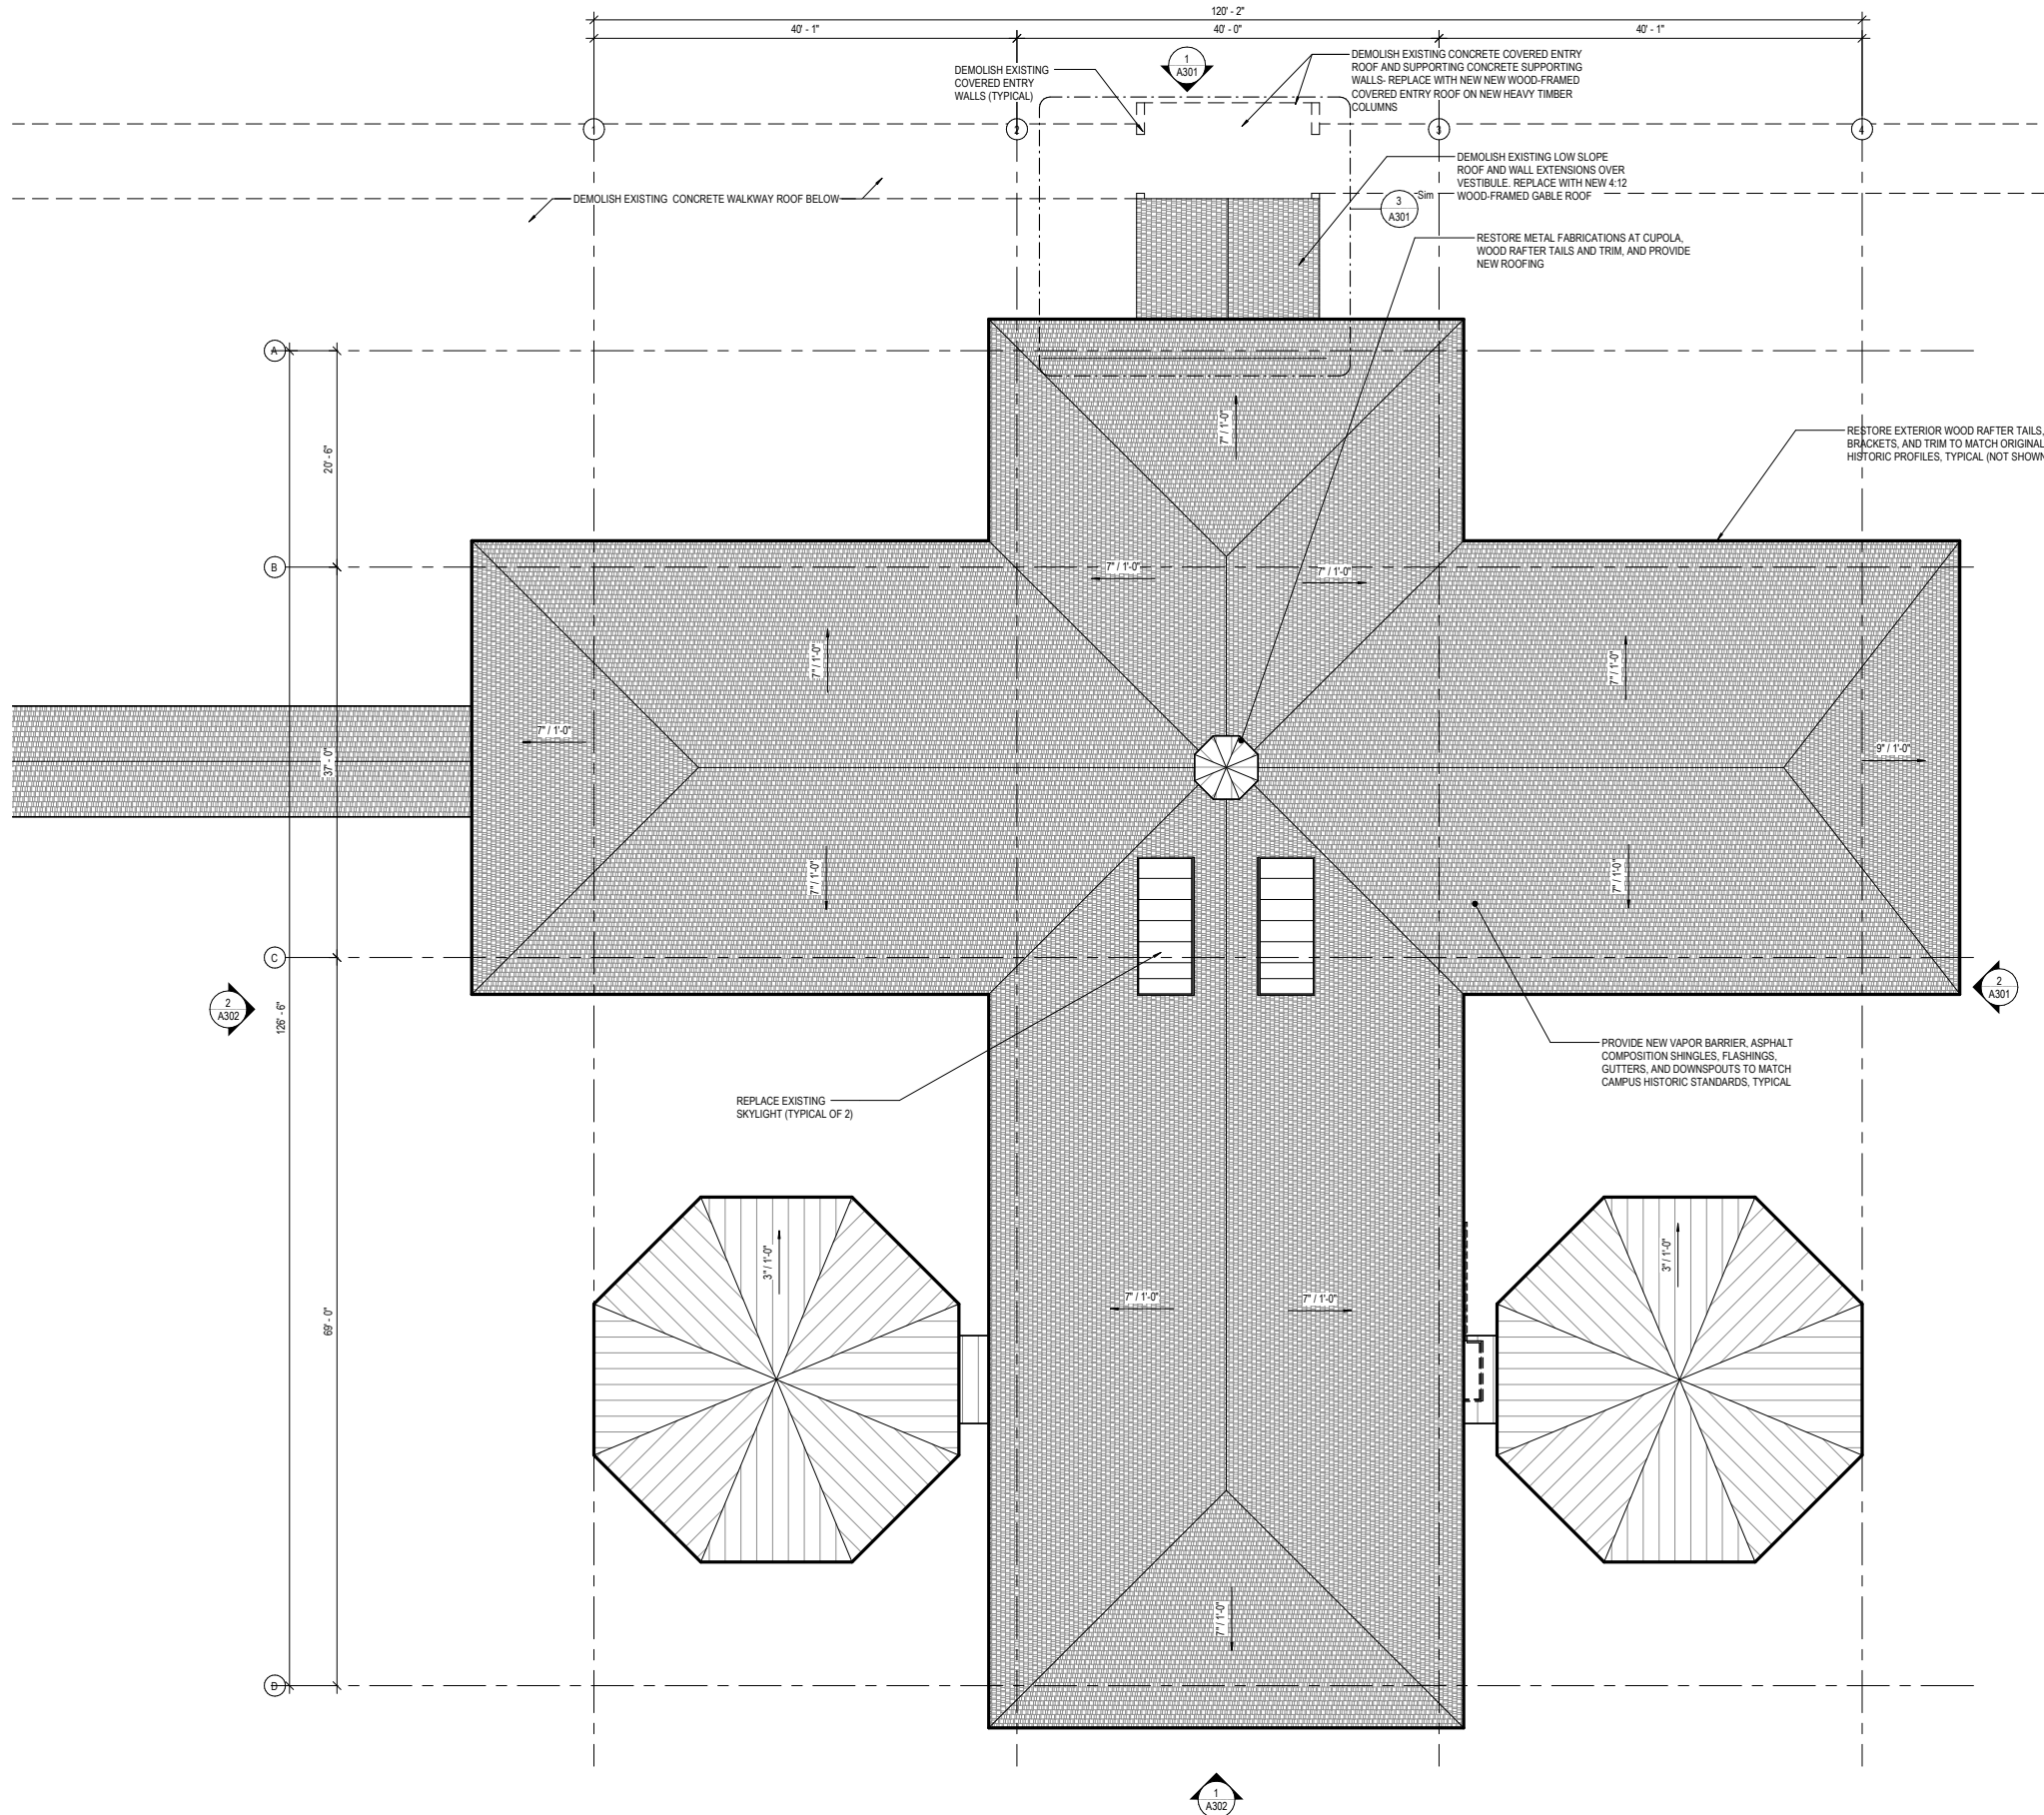
**A210**

1 Demo/Construction Roof Plan  
 1/8" = 1'-0"

replacement of all steel sash windows with double-hung assemblies, and new doors and finish hardware. The existing clay-tile roof needs to be removed to facilitate repair and replacement of steel truss framing. For cost savings, a new asphalt shingle roof system is proposed and the two existing skylights replaced. The enclosed walkway connecting Fraser and Gray will be reconstructed. New entrance vestibules are proposed at the north ends of Fraser and Gray to provide access from Hub Drive and adjacent parking and sidewalks.

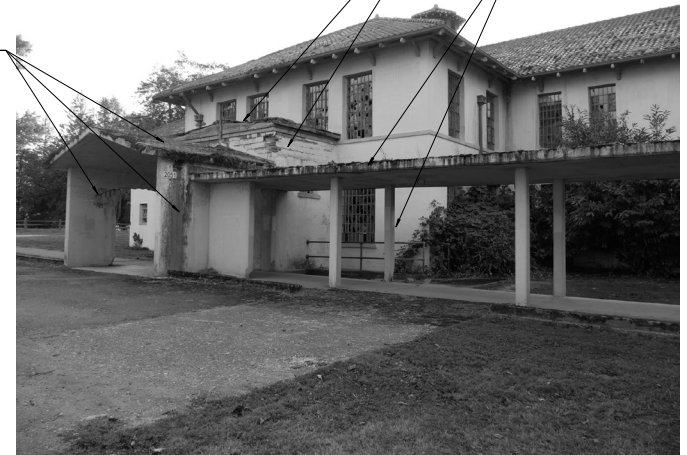
DEMO / CONSTRUCTION BUILDING ELEVATIONS  
**A301**

**2 Demo/Construction East Elevation**  
1/8" = 1'-0"

**3 Demolition and New Construction at Entry**

**1 Demo/Construction North Elevation**  
1/8" = 1'-0"
