## FRASER & GRAY BUILDING SCHEMATIC DESIGN

# Port of Skagit - SWIFT Center Rehabilitation of Gray and Fraser Buildings

Port of Skagit - SWIFT Center  
**Gray and Fraser Buildings Feasibility Study**  
 Northern State Hospital Campus  
 Sedro-Woolley, WA 98284

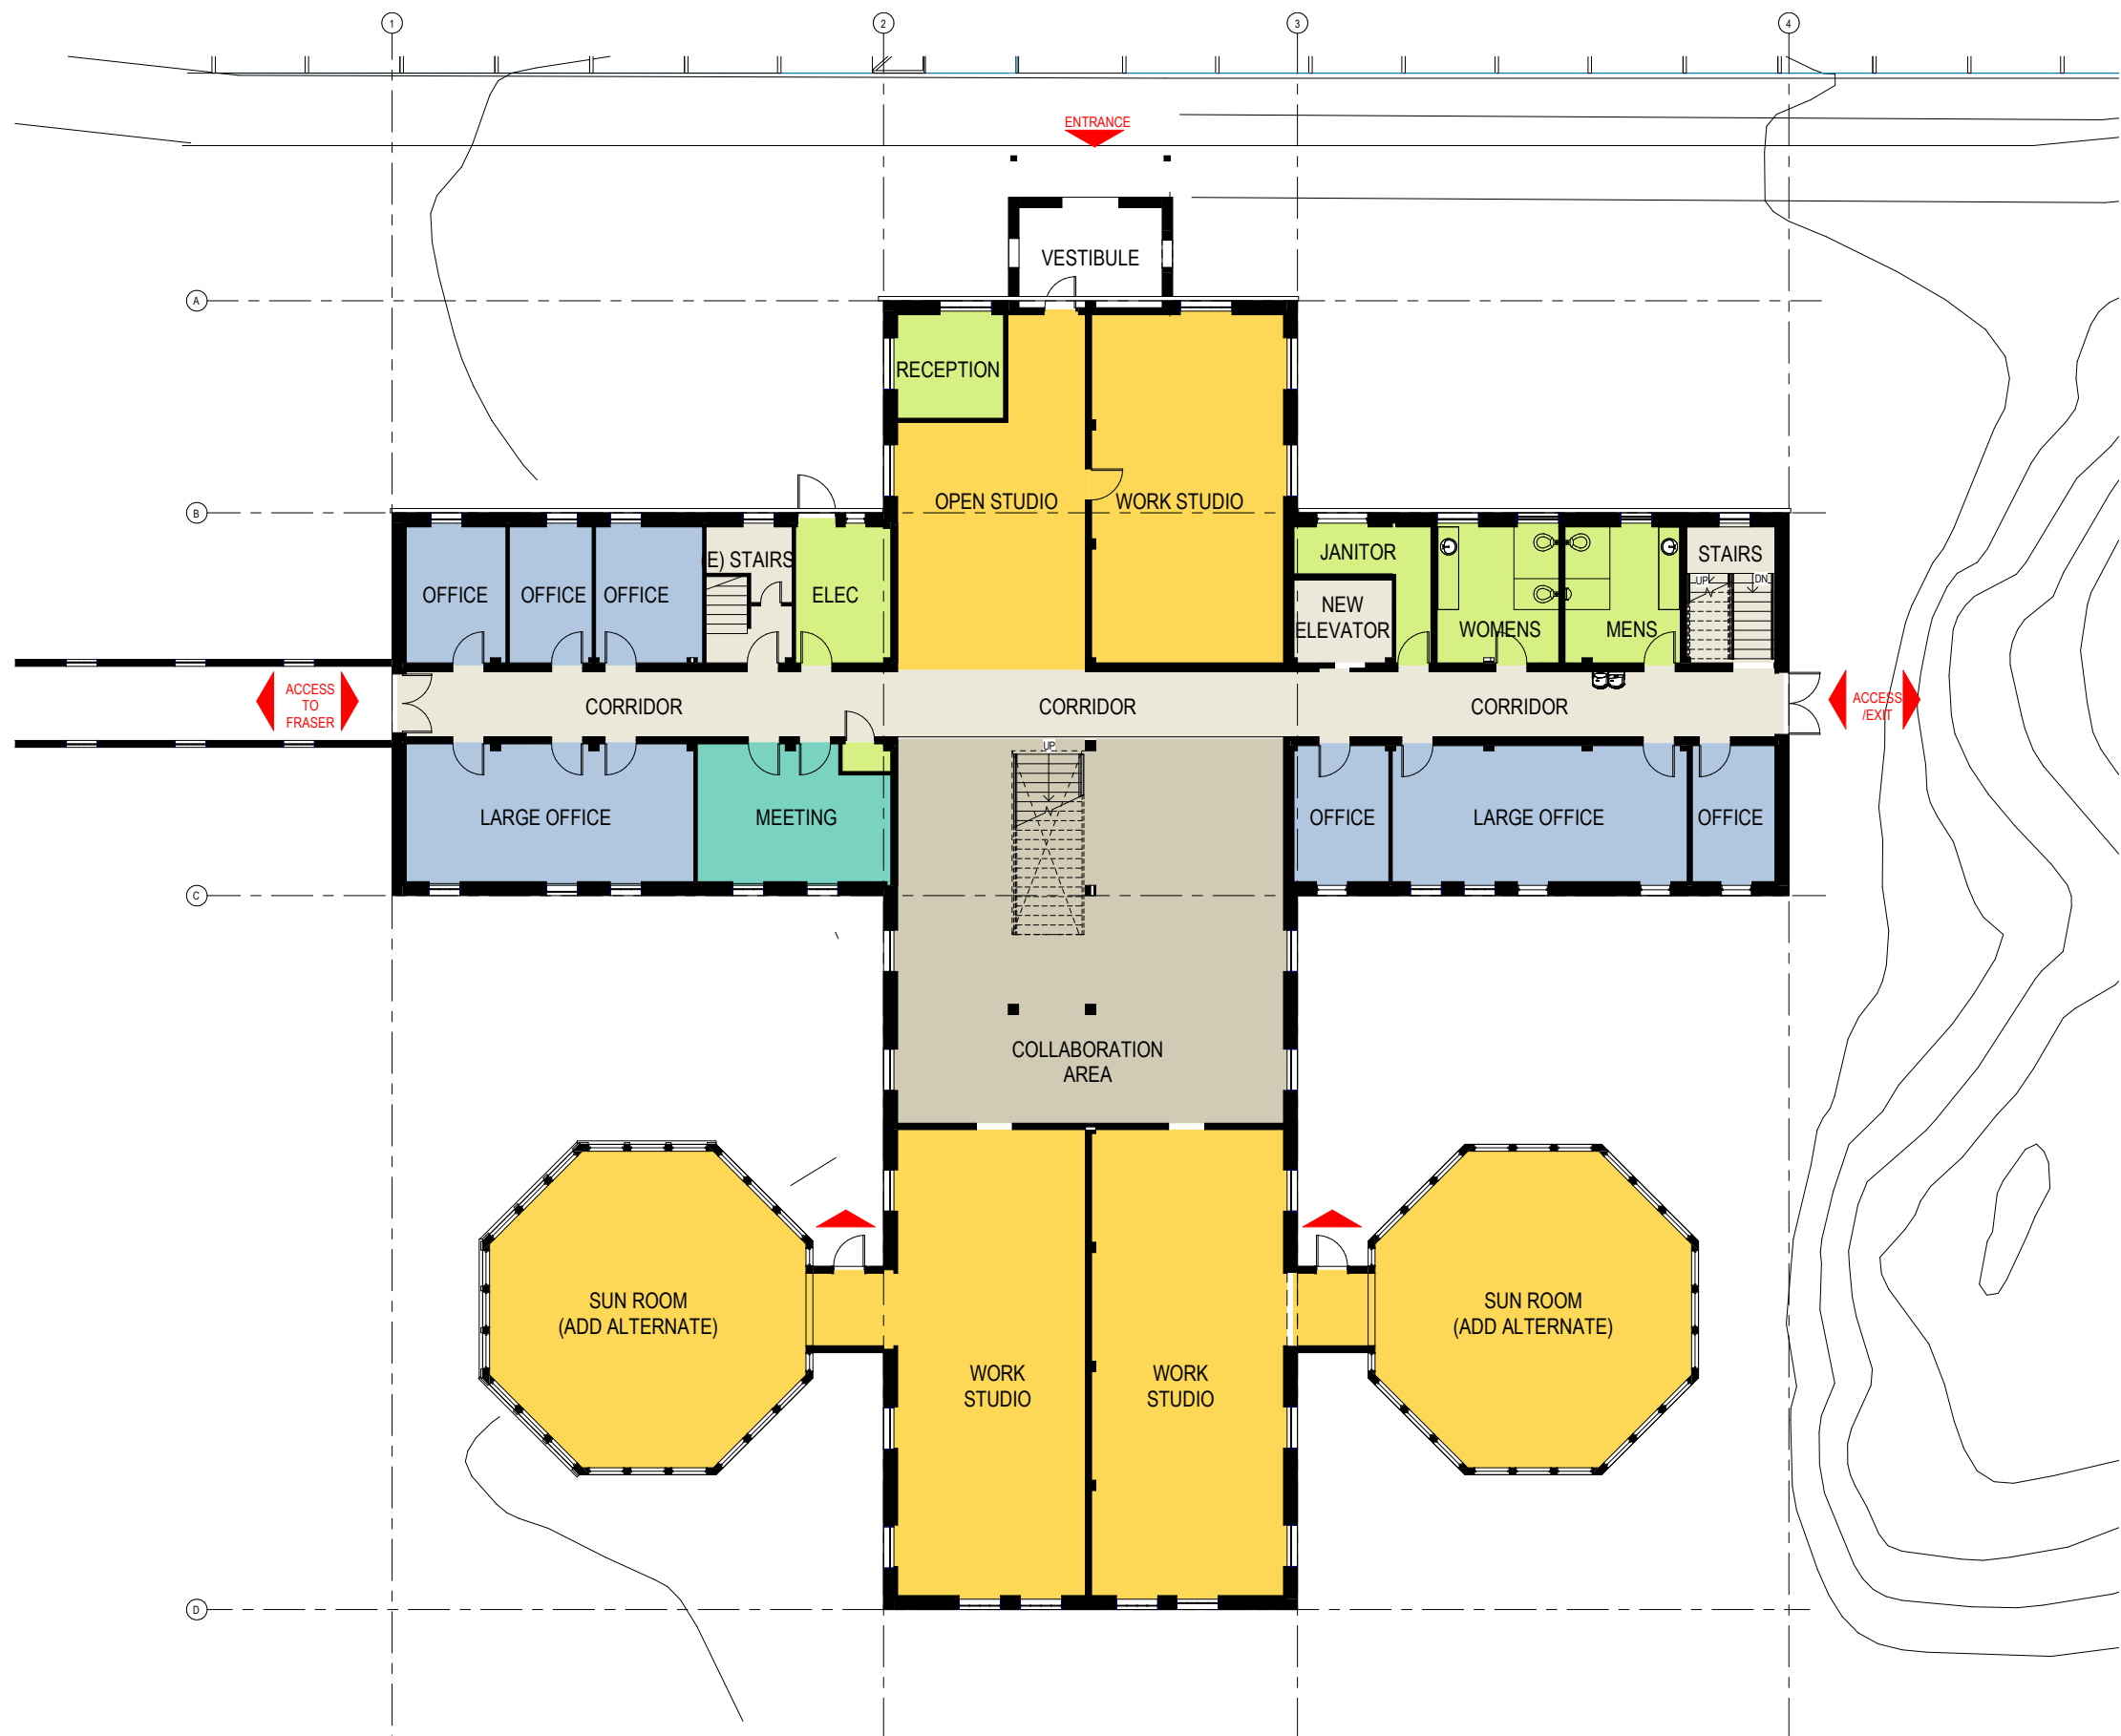
PRESENTATION  
 LEVEL 1 FLOOR  
 PLAN  
**P201**

**1** Presentation Level 1 Floor Plan  
 1/8" = 1'-0"

The project scope includes a change of occupancy from institutional/health care to educational, office, and low-hazard industrial use. The original floor plan and circulation routes are substantially maintained. A new stair is proposed for compliance with fire and life-safety requirements, along with an automatic fire sprinkler system throughout the building. Historic, non-complying stairs are refurbished or reconstructed entirely. A new elevator provides ADA access to the upper floor and basement mechanical space. By removing non-loadbearing partition walls separating former patient rooms, space is provided for larger offices, meeting rooms, and restroom facilities. The multi-bed wards serve as new classroom and studio work space.

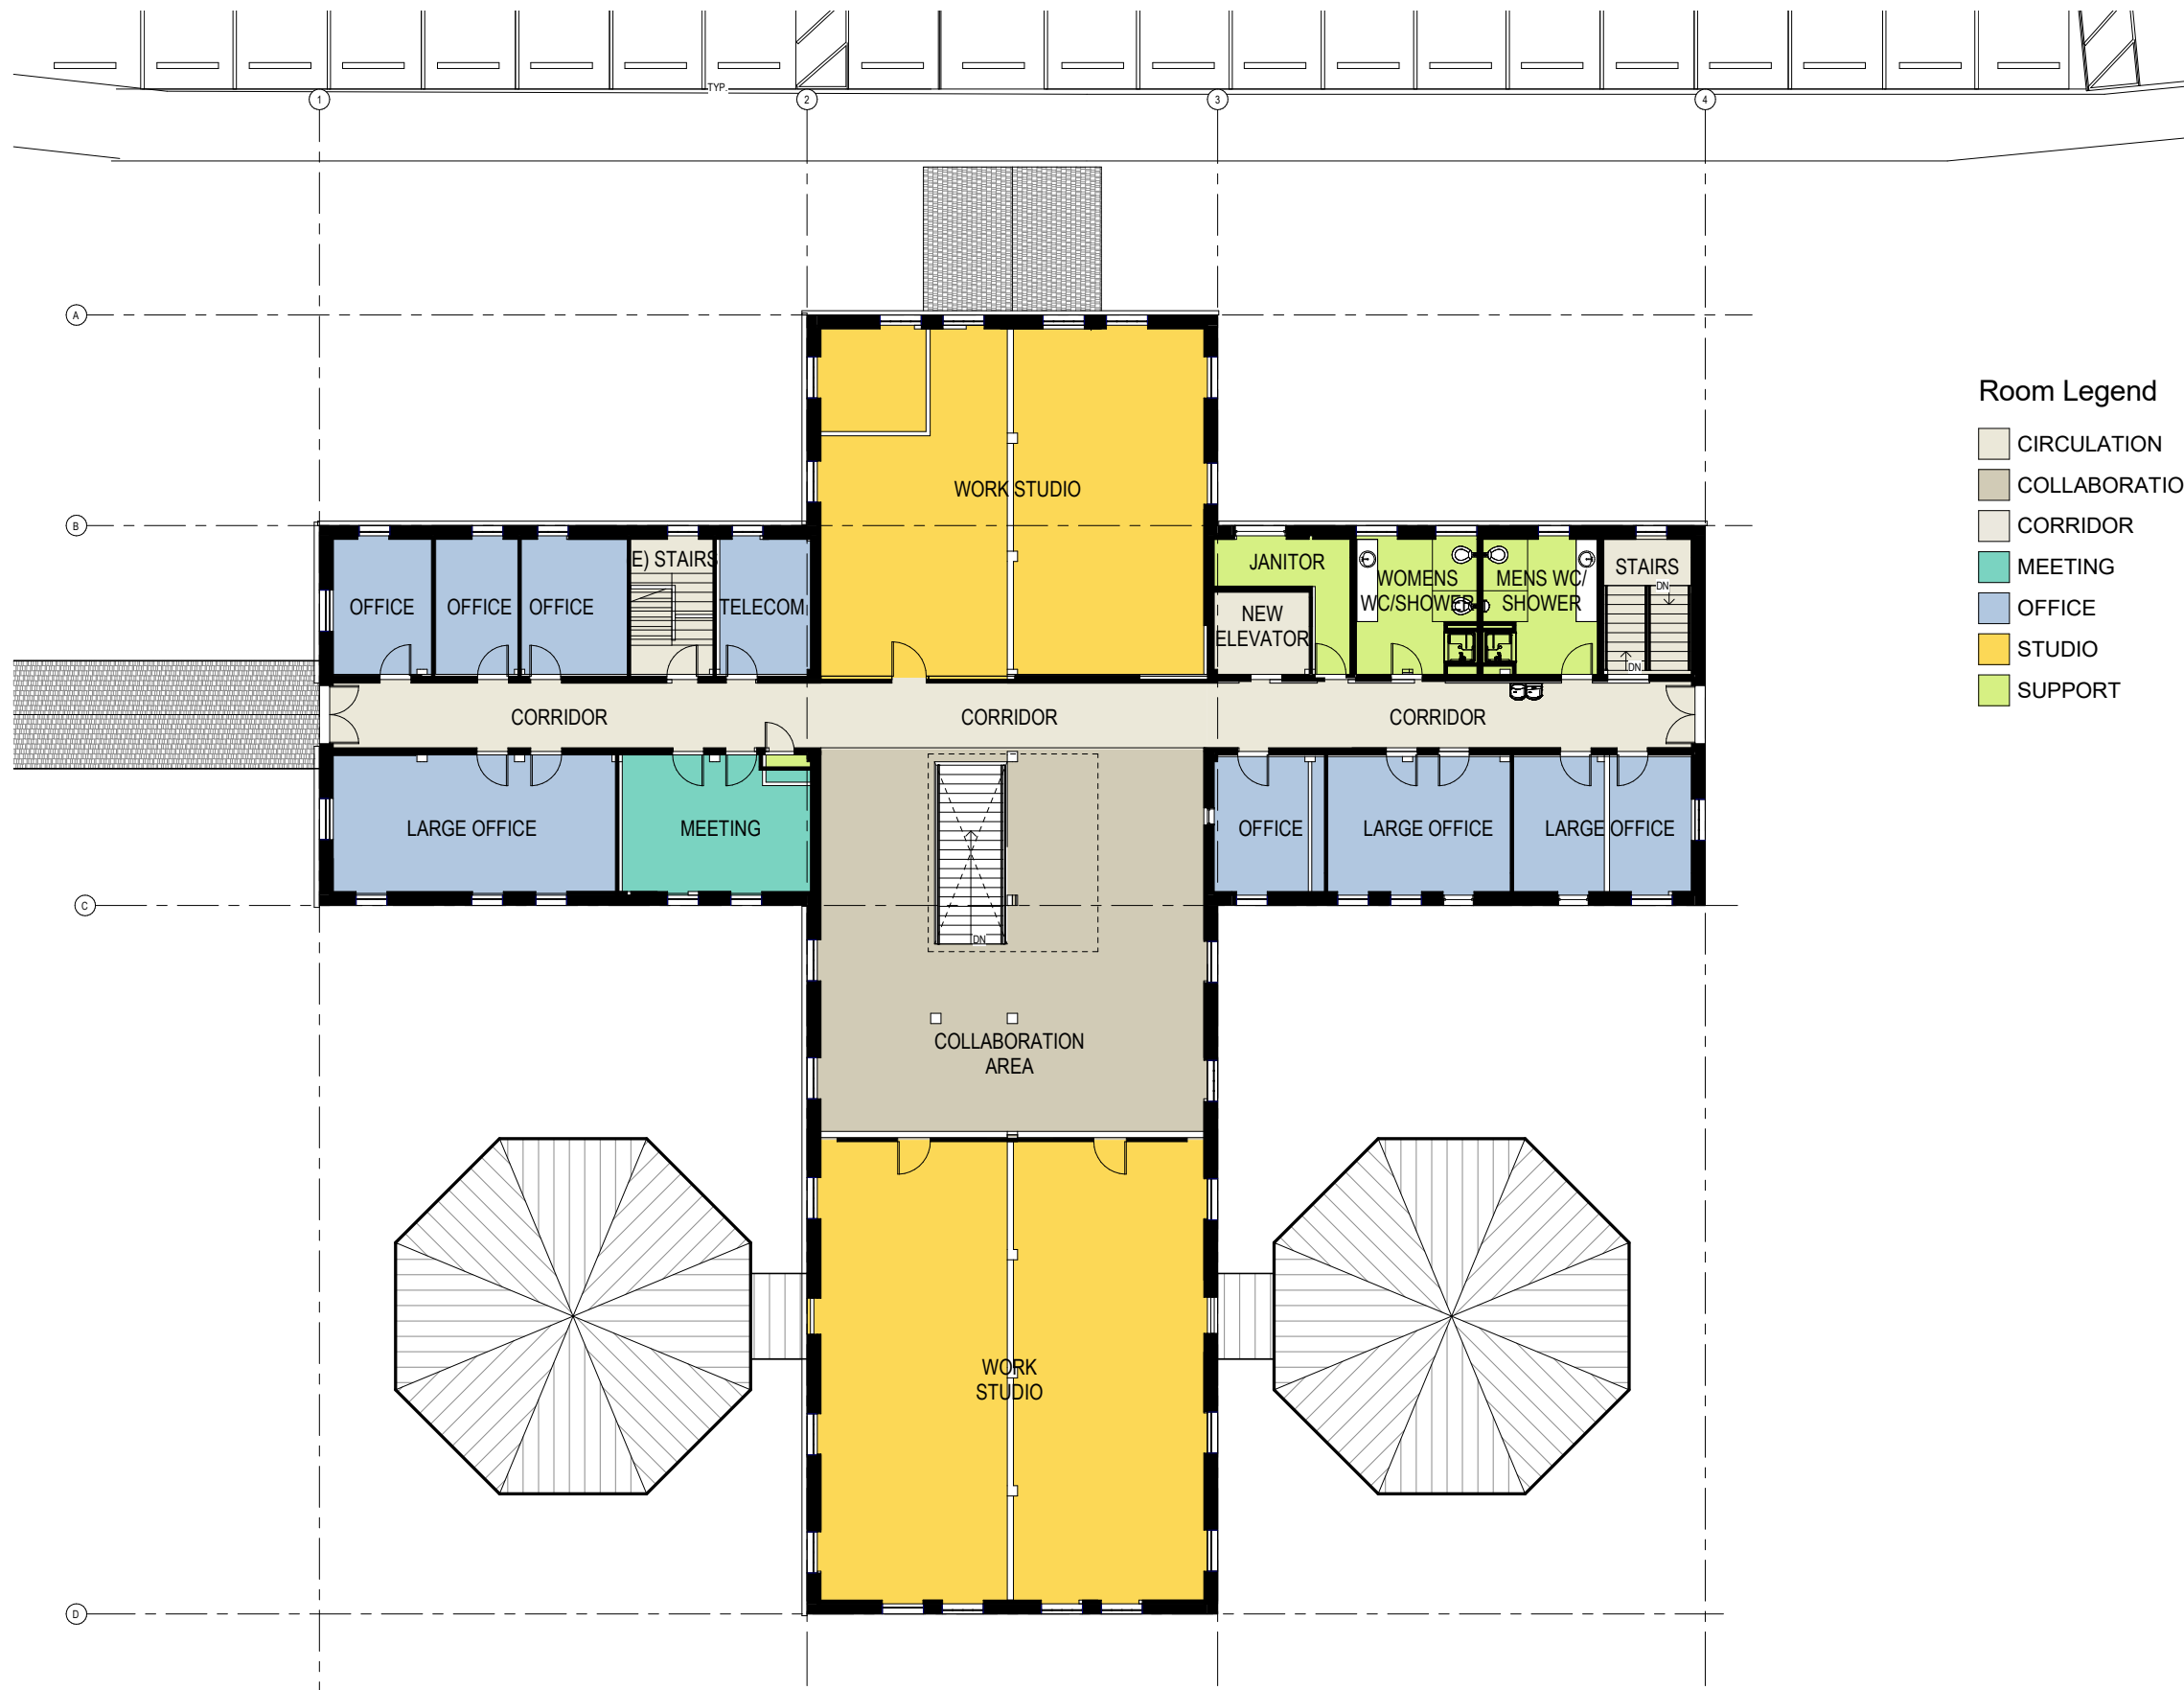
**1** Presentation Level 2 Floor Plan  
 1/8" = 1'-0"

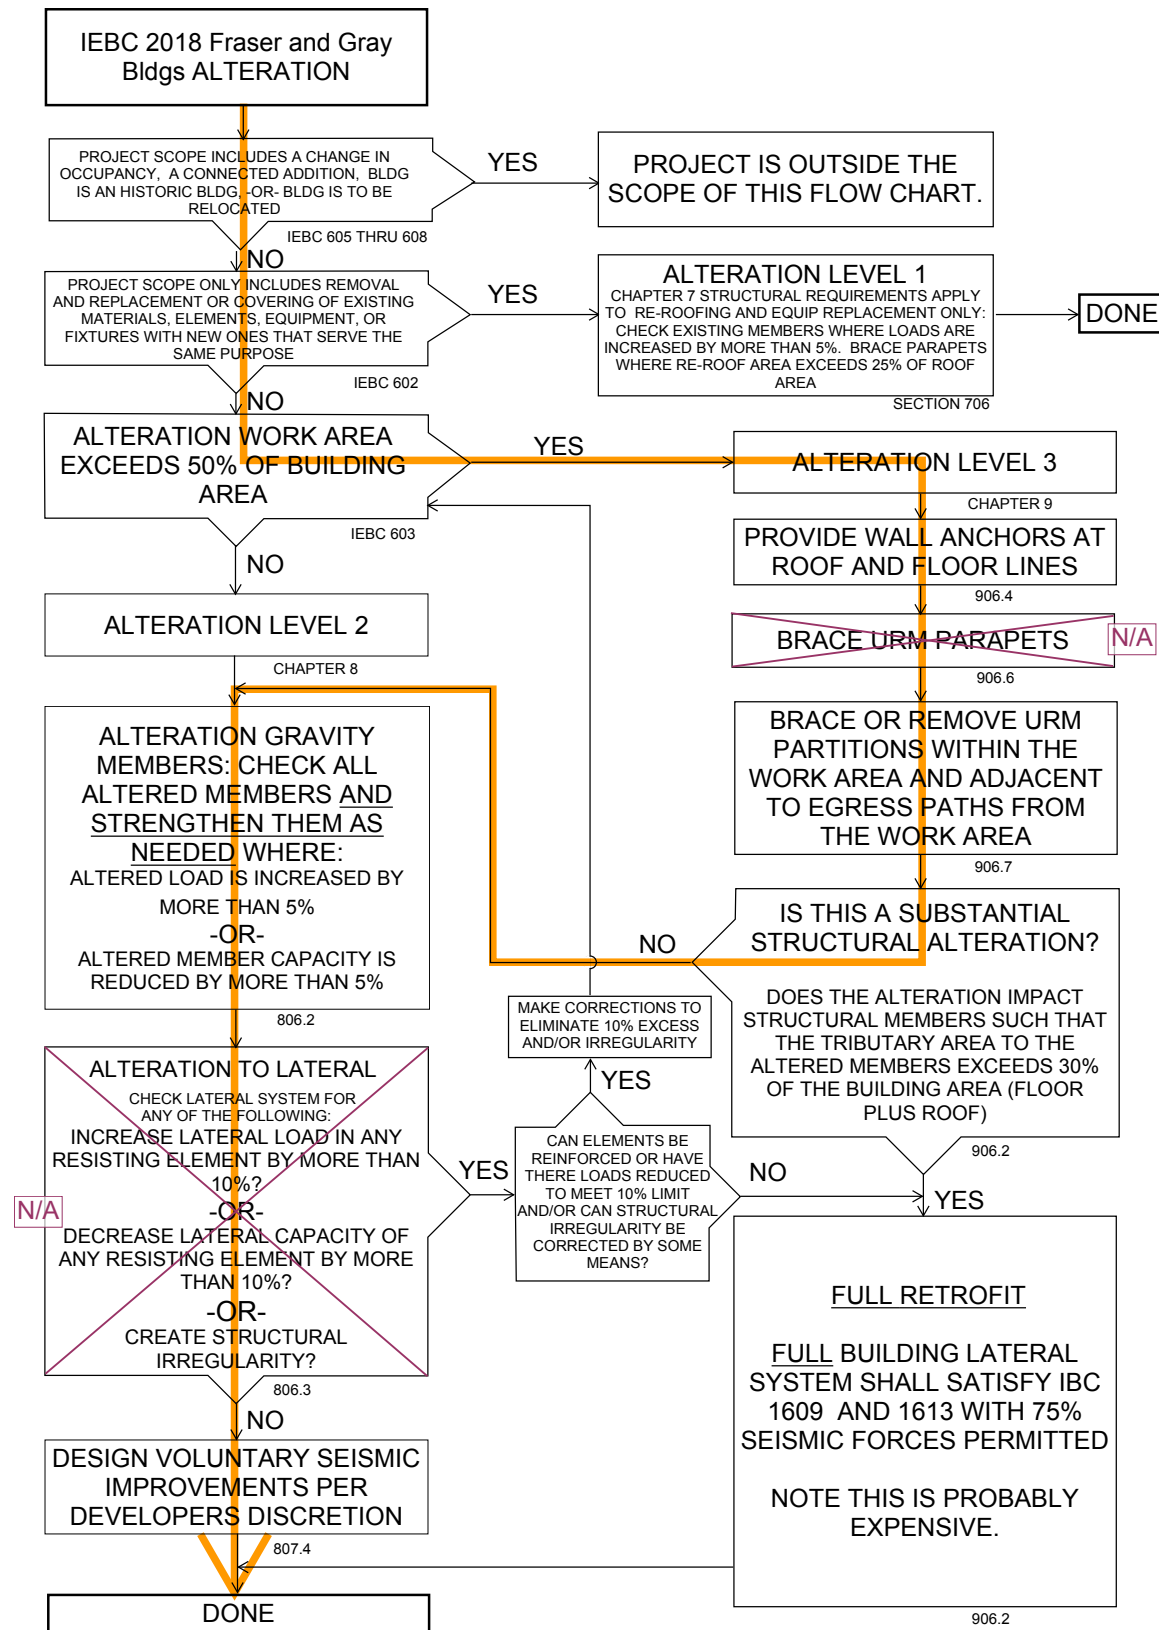
Fraser and Gray Bldgs IEBC Alteration Requirements Flow Chart		
	<small>NOTE: THIS IS A PRELIMINARY SYNOPSIS OF THE IEBC STRUCTURAL REQUIREMENTS AND IS INTENDED TO DEMONSTRATE THE STRUCTURAL ASPECTS OF THE REQUIREMENTS TO OUR CLIENTS. CONSULT THE FULL IEBC TEXT AND BUILDING OFFICIAL FOR THE EXACT REQUIREMENTS</small>		
600 Dupont St, Suite B Bellingham, WA 98225	360.714.8260 www.king-works.com	Project number 22090 Date 8/29/22 Drawn by JKING Checked by JKING	<b>SSK-01</b>  Scale NTS

Attachments:  
SSK-01 Fraser & Gray Buildings IEBC Flowchart  
SSK-02 Elevator Pit Sketch

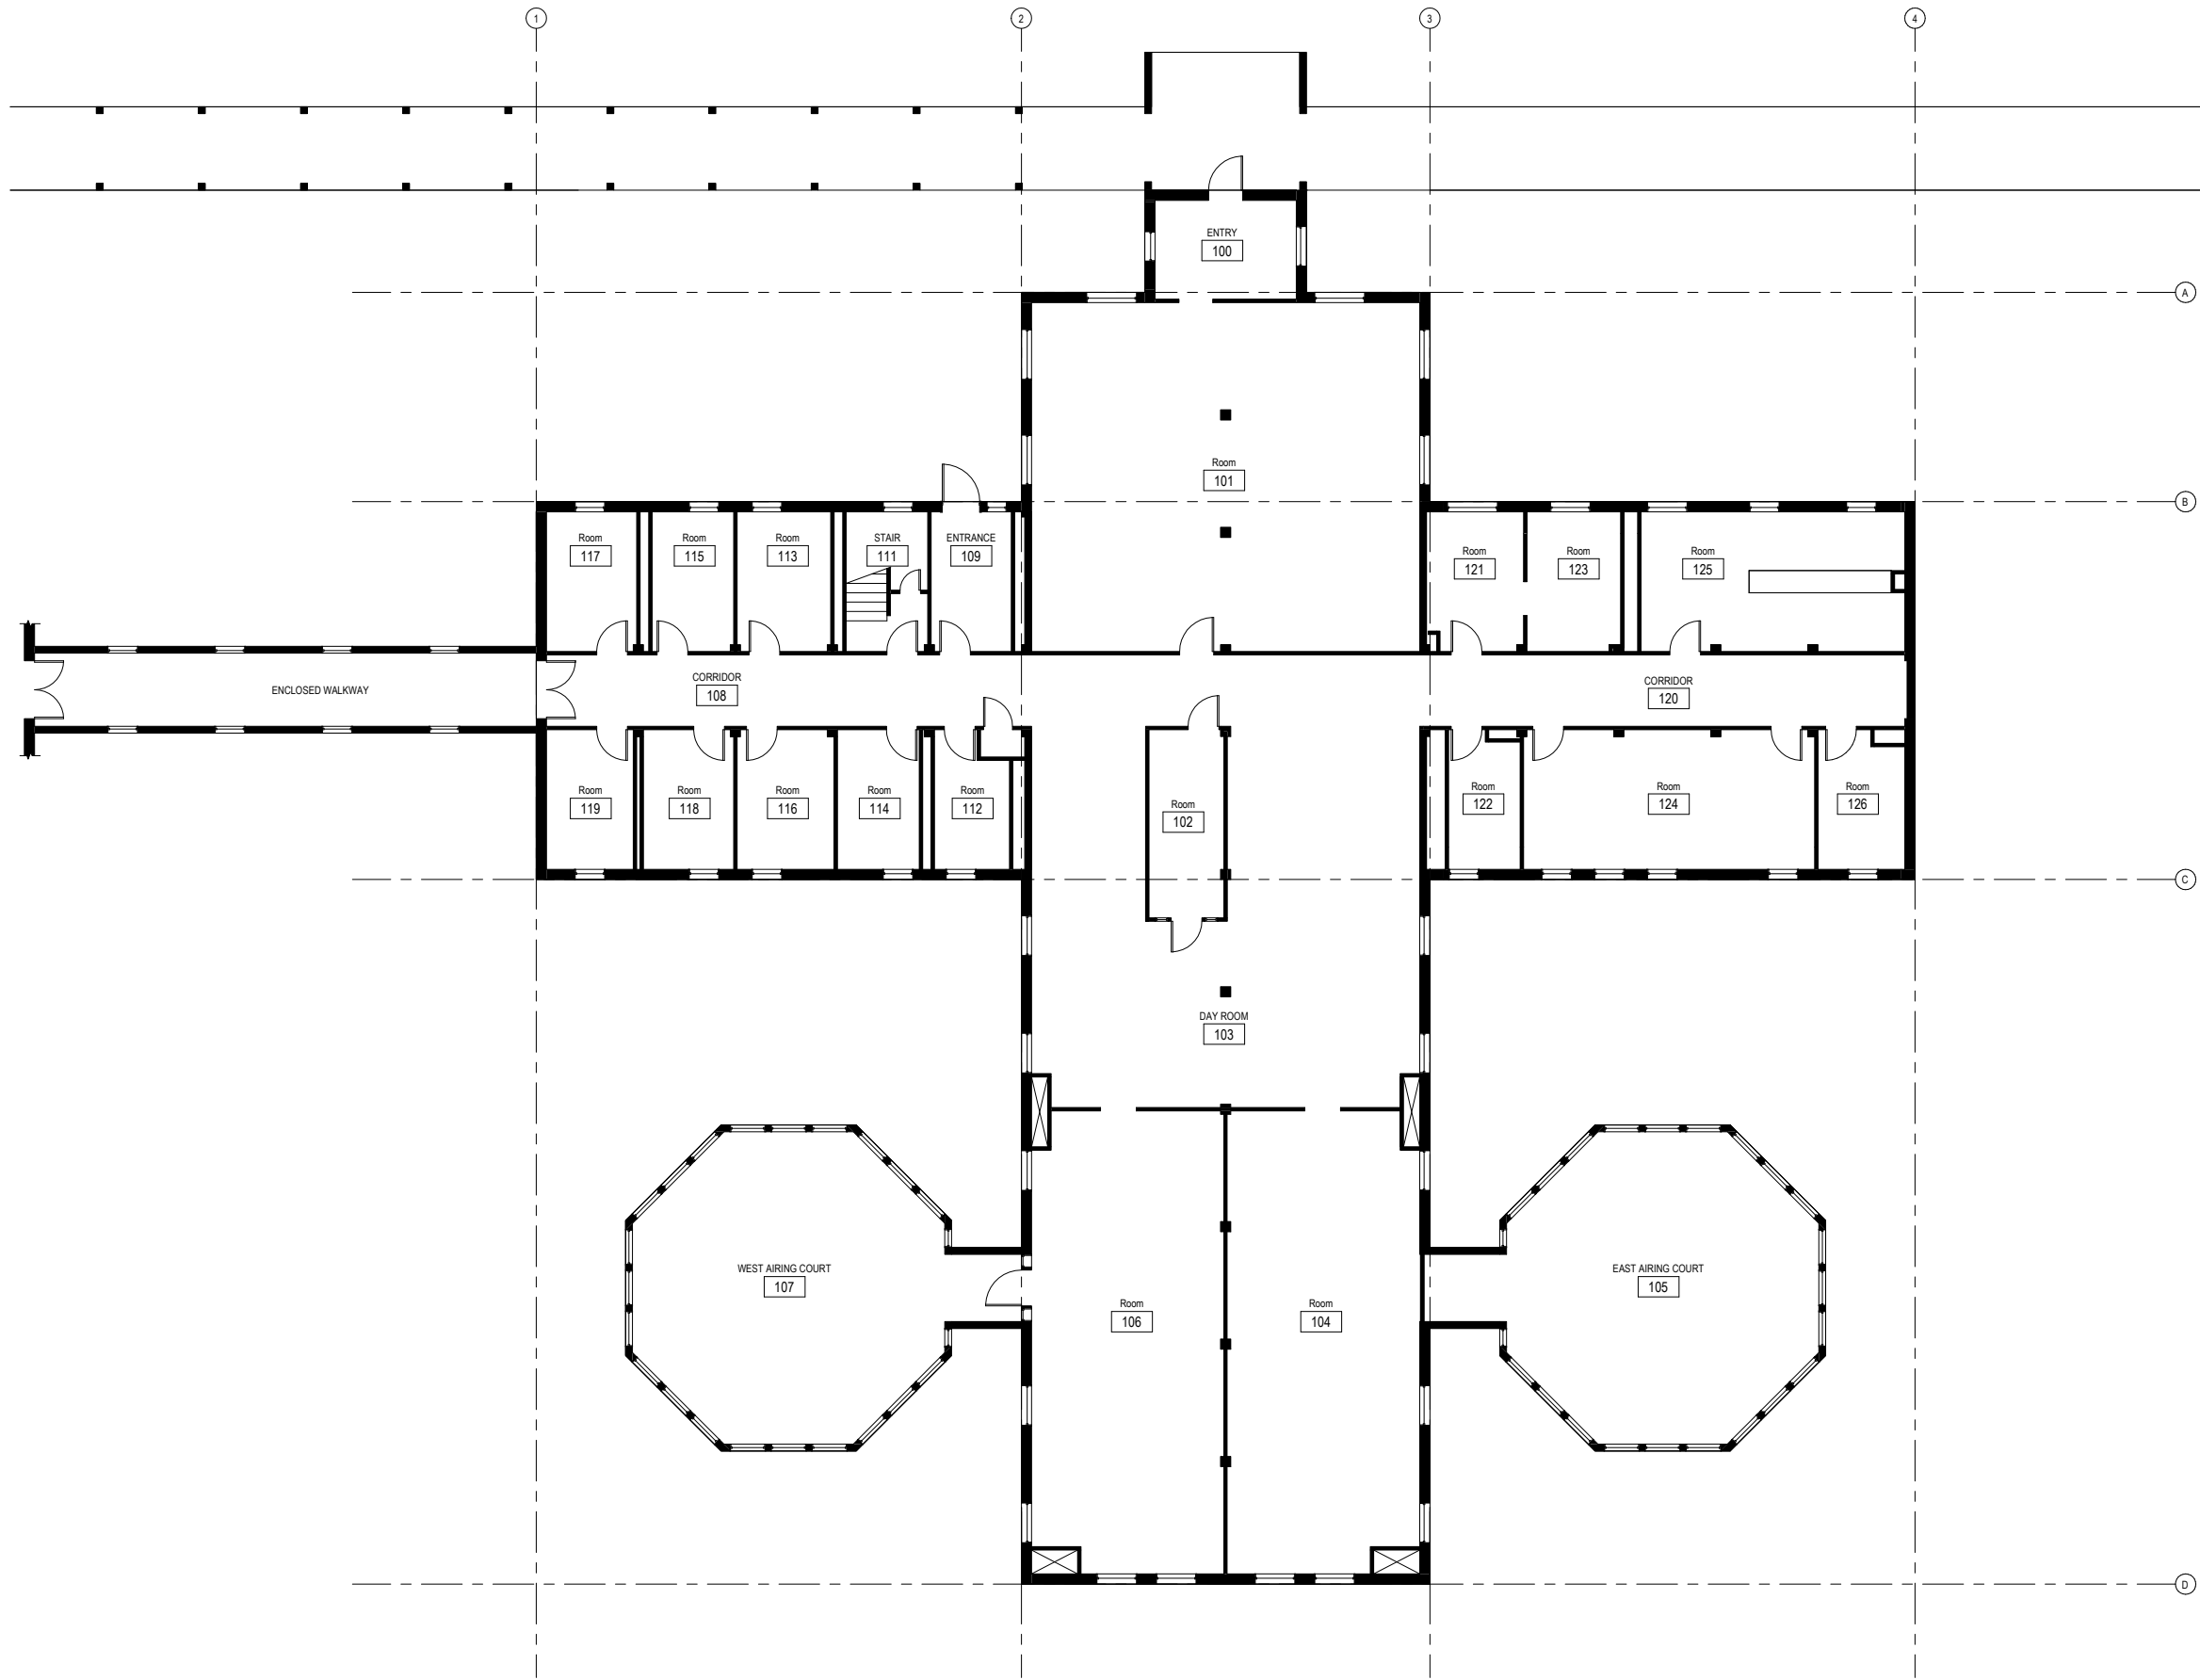
FIRST FLOOR  
 EXISTING  
 CONDITIONS

**1** First Floor Existing Conditions Plan  
 1/8" = 1'-0"

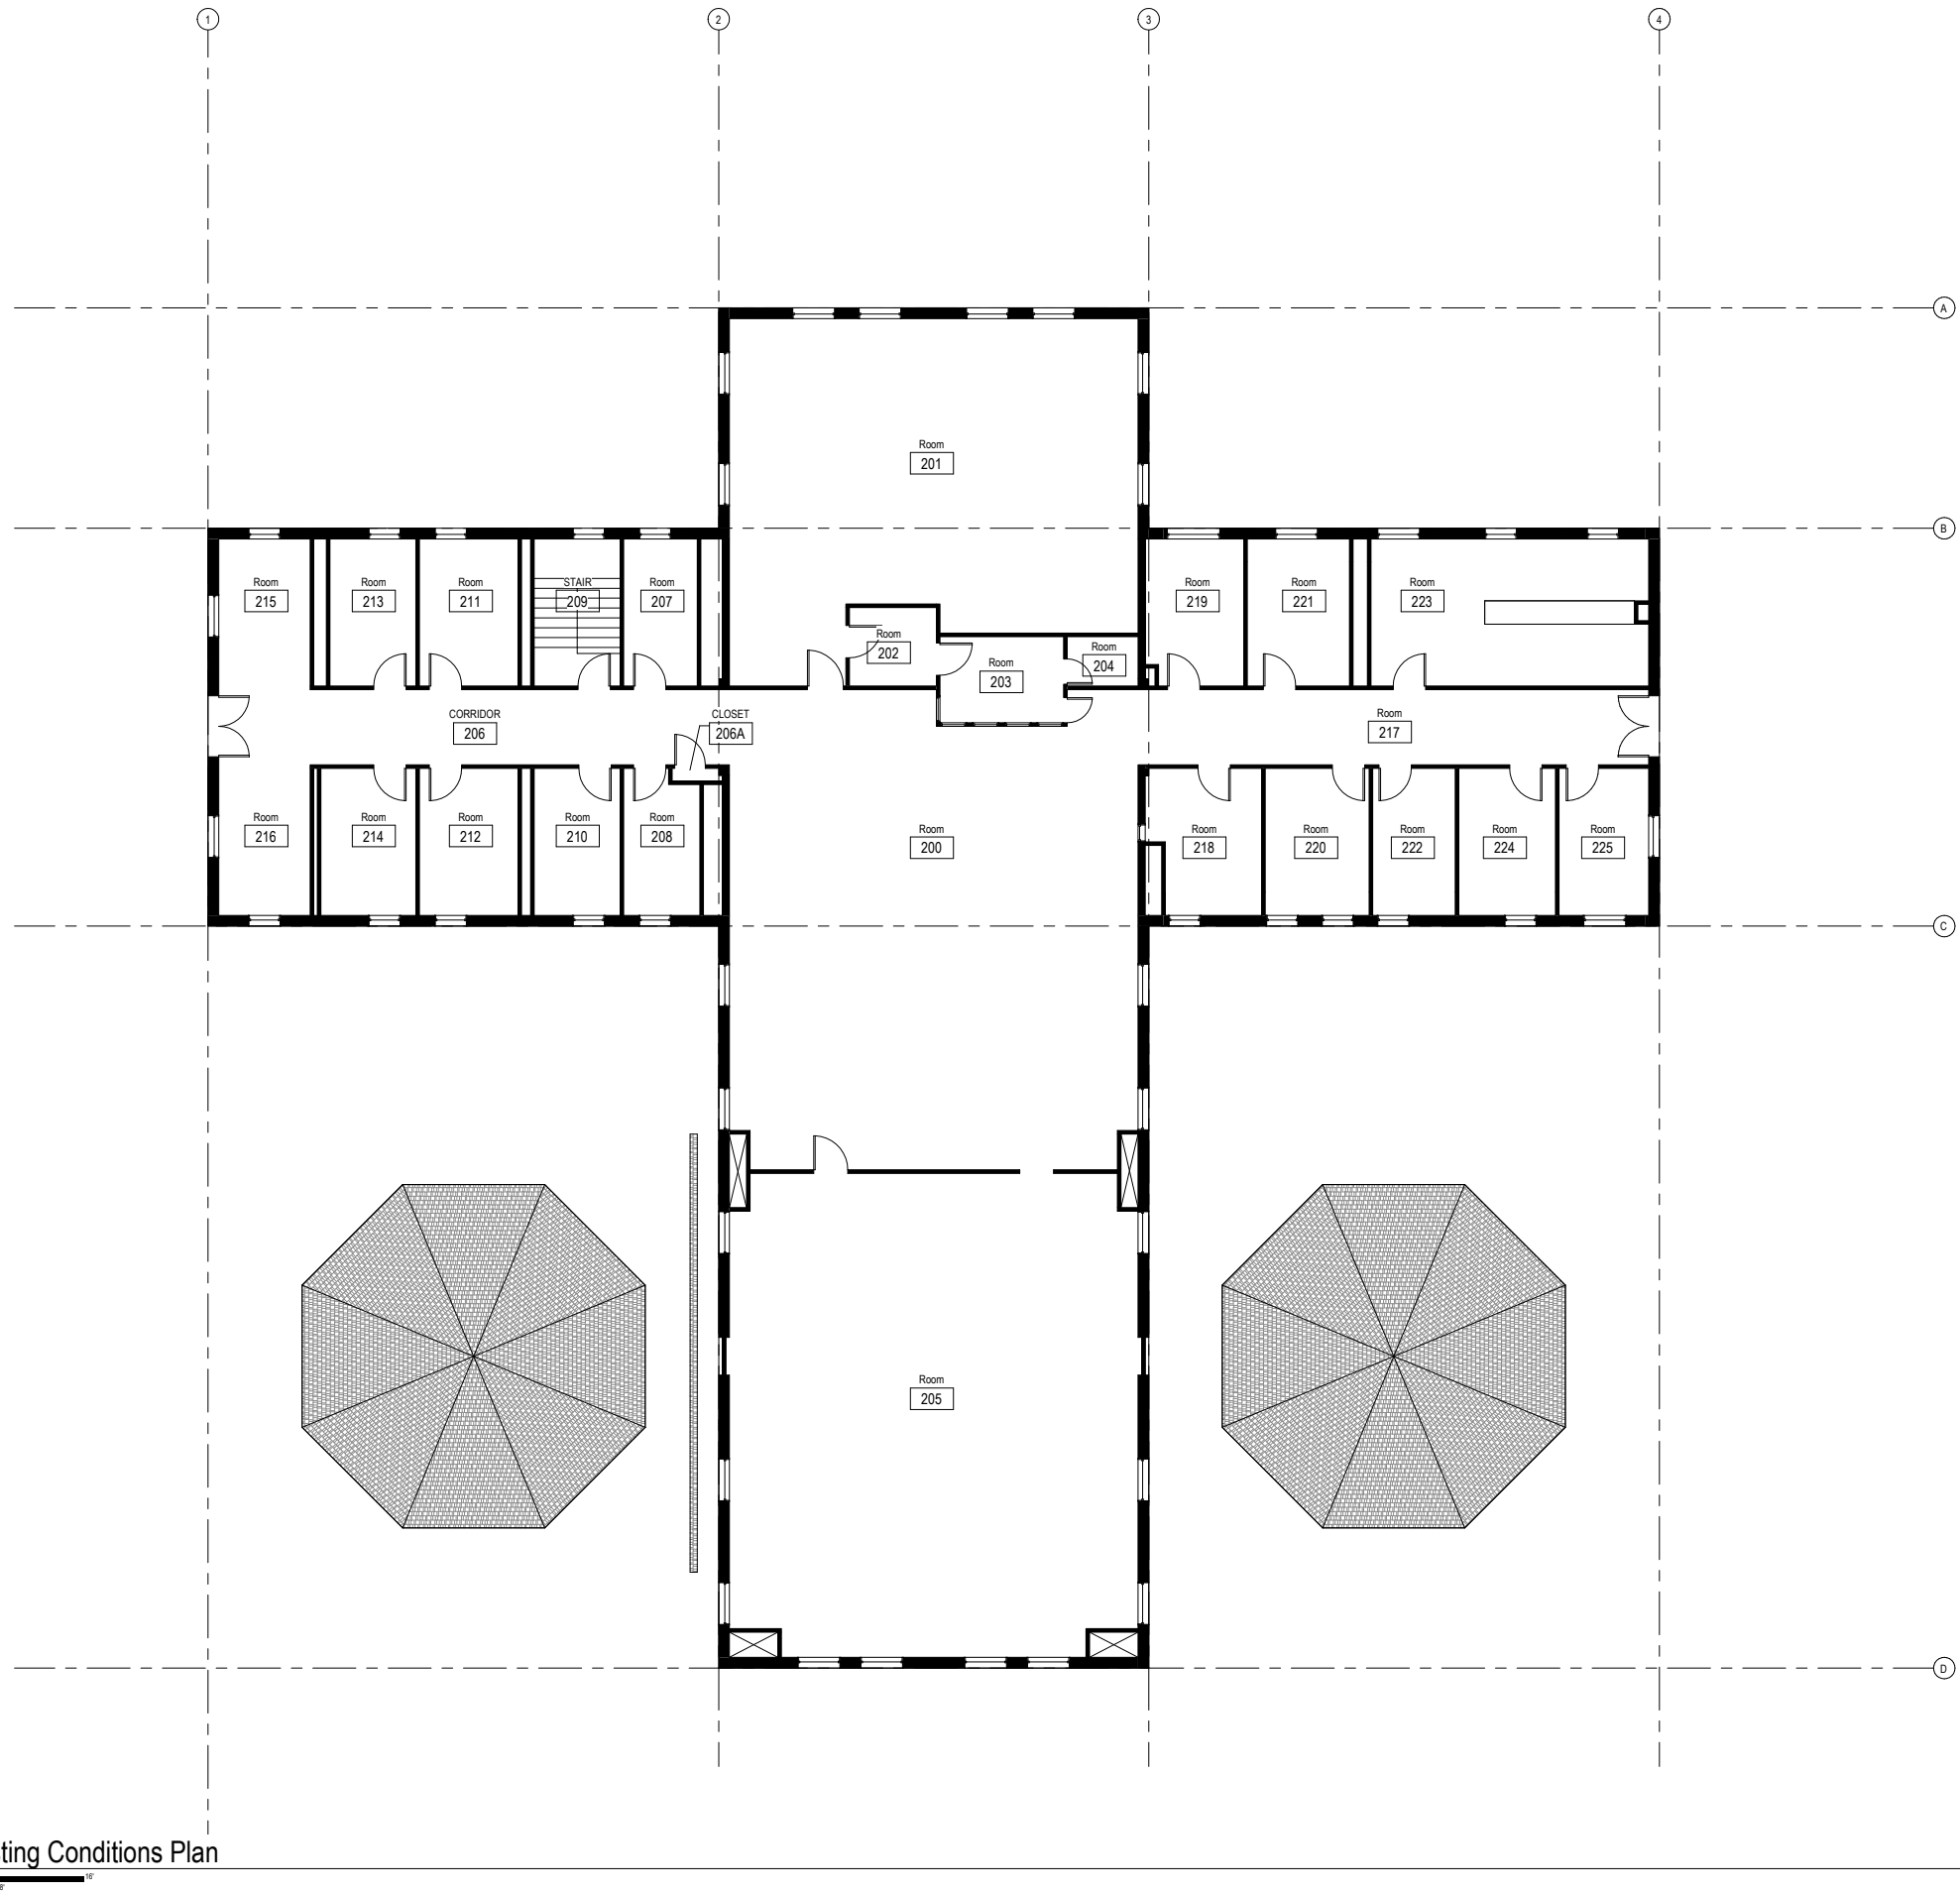
SECOND FLOOR  
 EXISTING  
 CONDITIONS

1 Second Floor Existing Conditions Plan
